Property Inspection Report

403 Woodale Dr, Kennett Square, PA 19348

Date of Inspection: 3/27/2026 Time: 10:00 AM

Inspector: Patrick Baronsky
License #256972

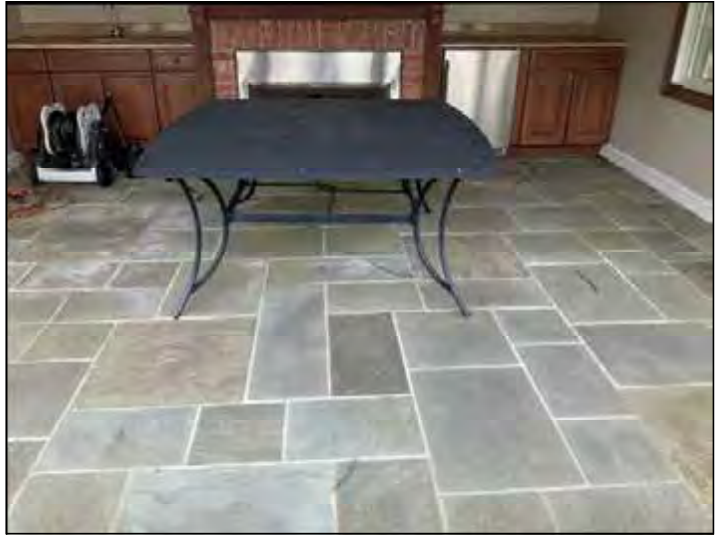
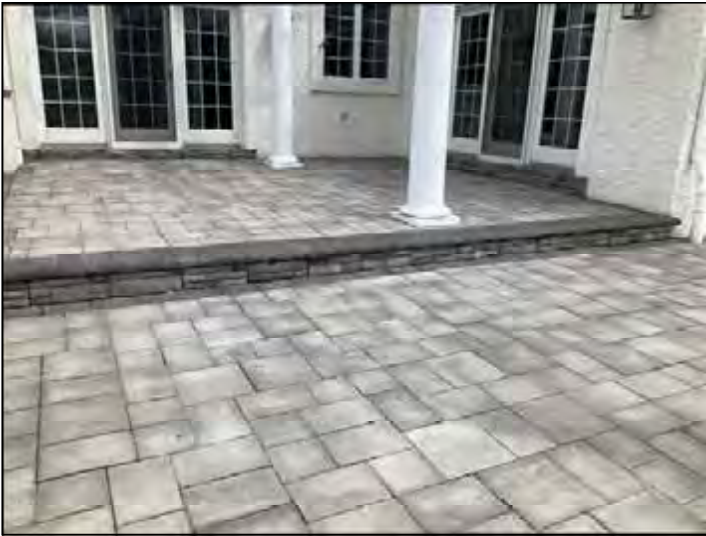
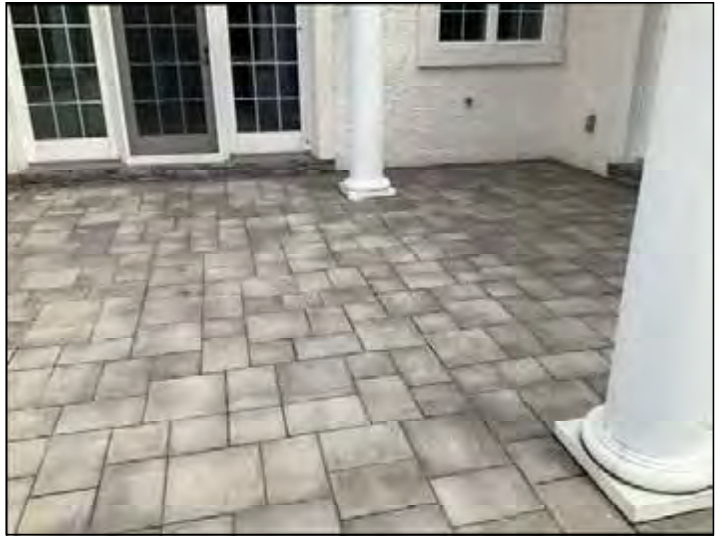
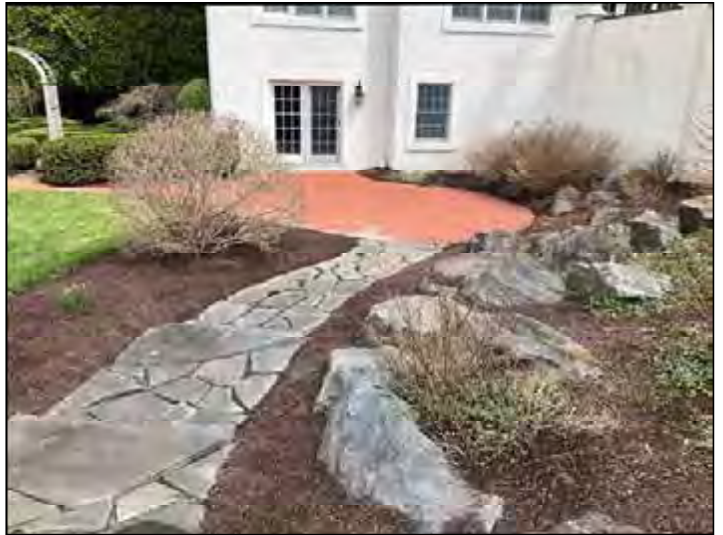
3. Patio

- Pavers damaged/deteriorated, recommend repair.
- Exterior outlets are not protected by a GFCI, recommend repair.

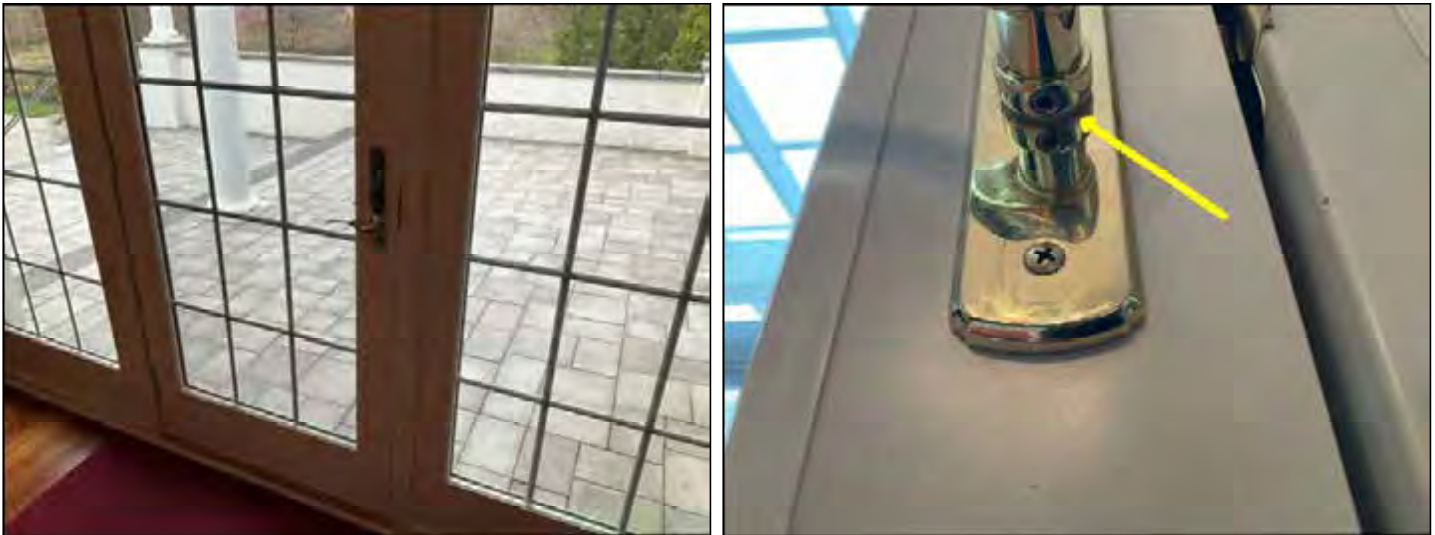
- **Patio door handle set screw loose, repair. Location: Upper and lower doors.**

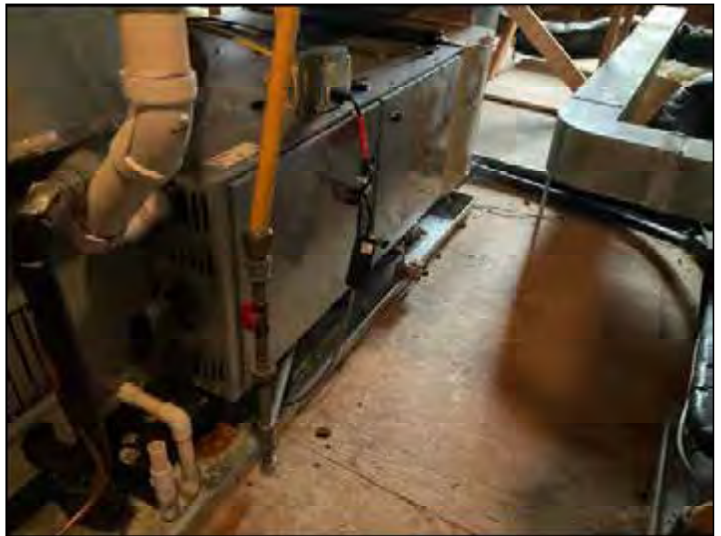
1. Condition

- Estimated/Reported Age 10 Years Life Expectancy 25-30 Years Forced Hot Air Gas Per unit
- Air handler/Heating units installed at areas above living space should have tray and drain installed to help in the event of leaks. Note safety cut off switches are unreliable and often fail. Recommend installing drain to the exterior. Location: Both units

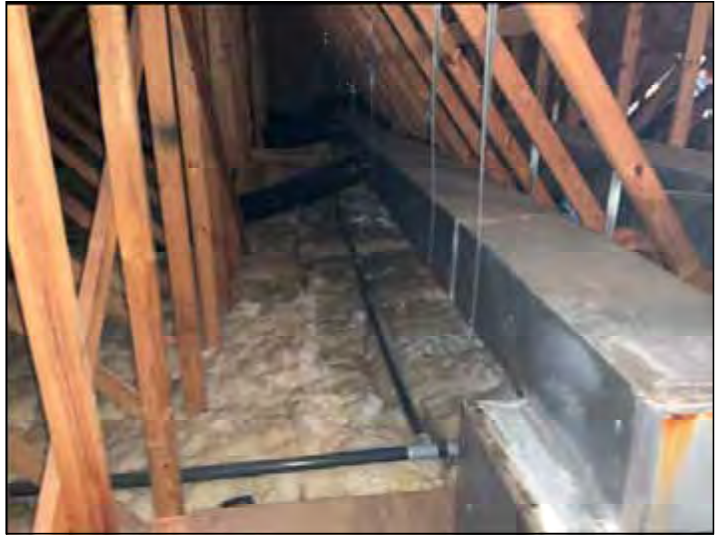
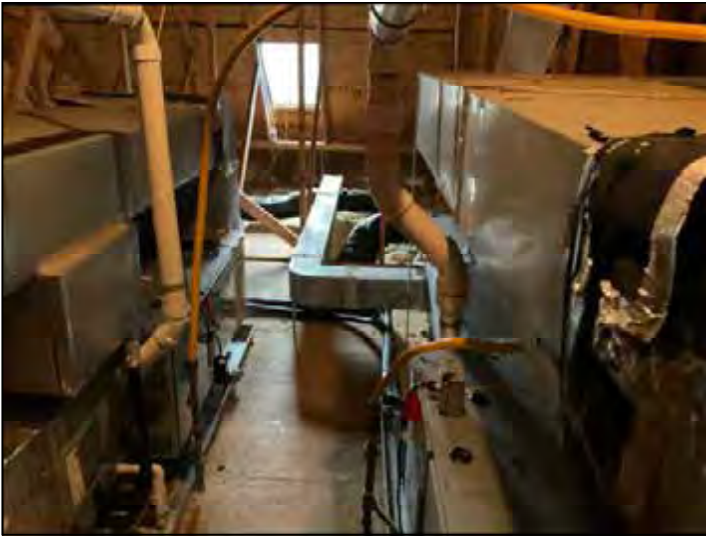
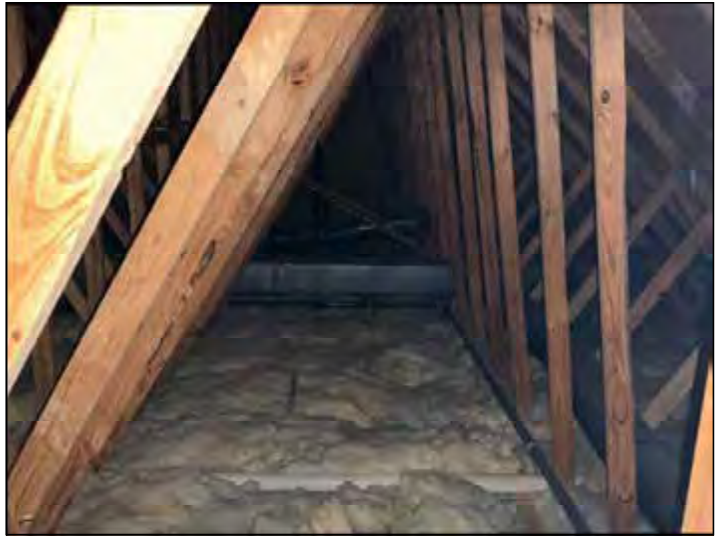
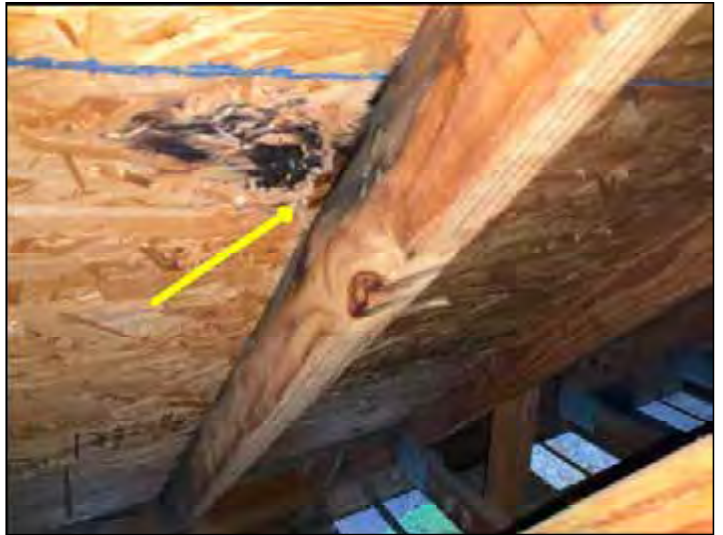
2. Structure

- No concerns at the time of inspection.
- Unable to complete a full inspection due to personal storage/construction
- Evidence of past or present leak at time of the inspection, repair. Location: Center dormer window.

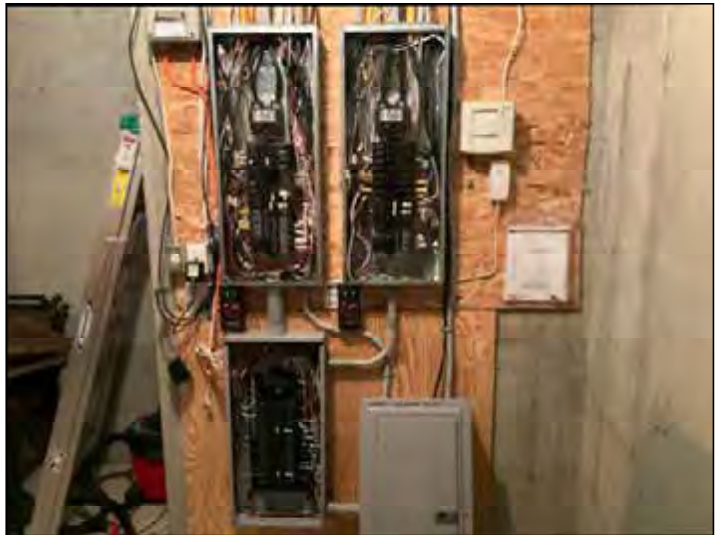
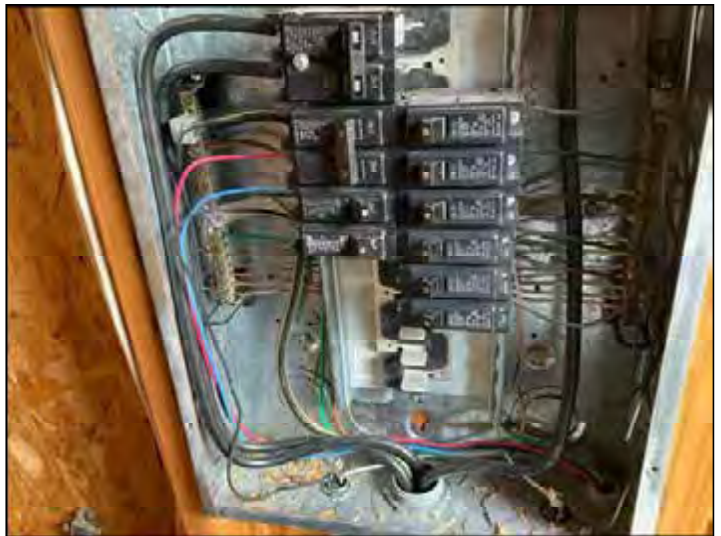
2. Electrical Panel

- 200 Amp Service Noted
- Generator noted during inspection, recommend separating neutrals and grounds on opposite bars to prevent power surge. Location: Main panels.
- We recommend contacting a licensed electrician to evaluate and repair the issues.

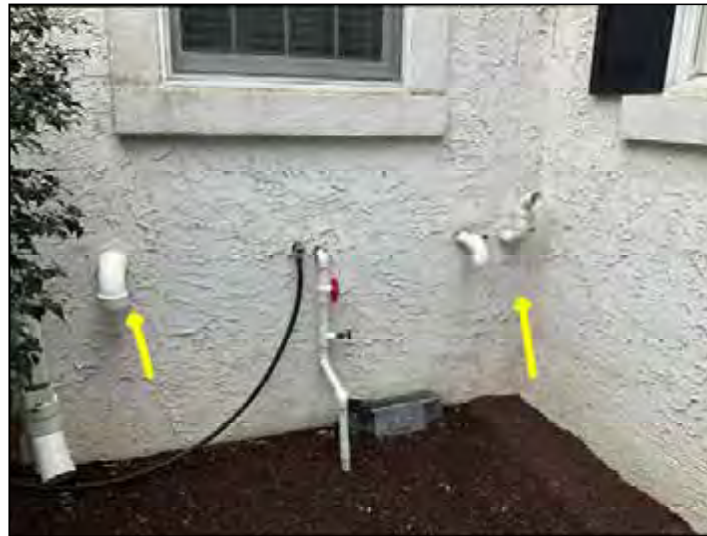
2. Heater Condition

- Plastic - **PVC** vent noted.
- Fuel appliance exhaust, should terminate at least four feet below or horizontally from door, window, or air inlet. Location: Right side and left side by AC condensers.

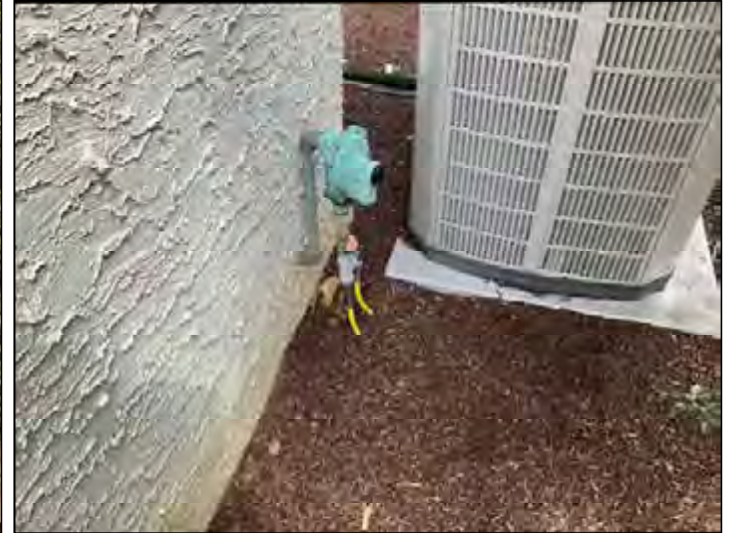
1. Gas Material

- **Safety Concern:** House equipped with CSST gas supply lines should be bonded and grounded properly. Recommend that you contact a licensed electrician to repair.

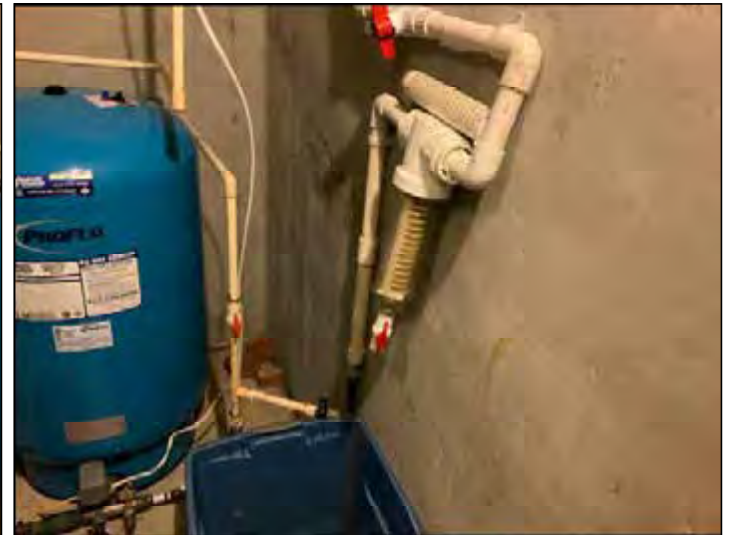
4. Well

- This inspection is a visible inspection of well controls, recommend licensed well technician to inspect and certify.
- Open junction boxes were observed, which is a safety concern. Recommend installing proper covers, as needed, for safety.

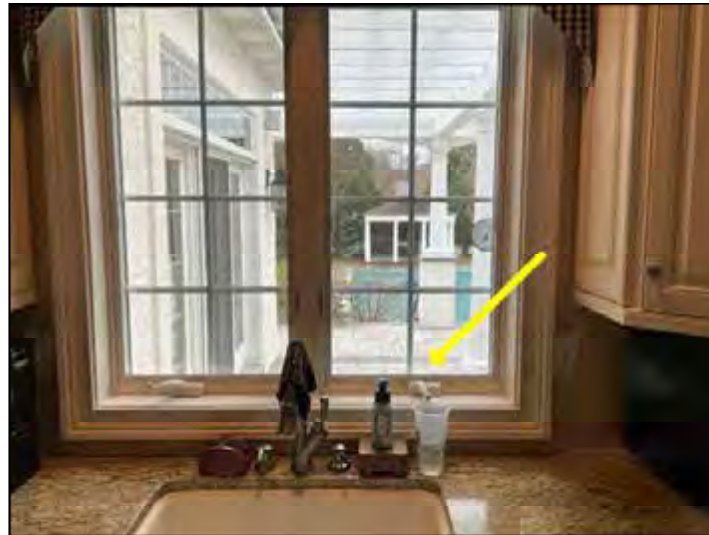
2. Window Condition

- One or more windows did not lock/latch/open properly. Recommend repairs for enhanced security/safety to occupants. Location: Right side of sink.

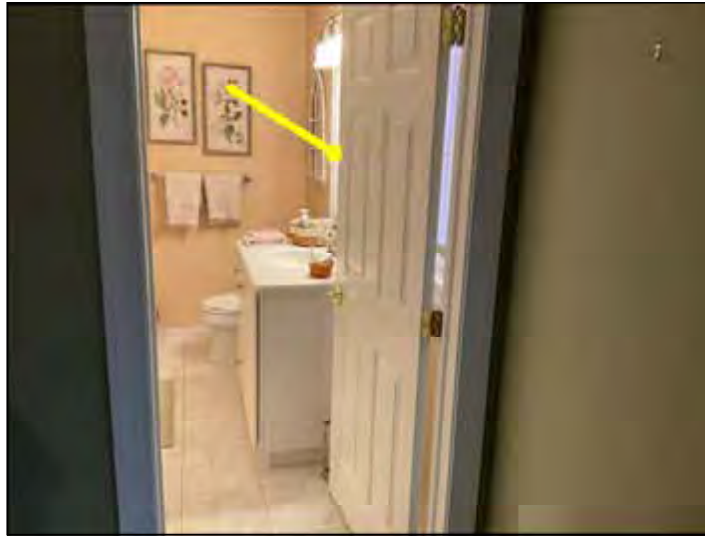
- Door doesn't latch properly, recommend repair. Location:. Middle rear bathroom.

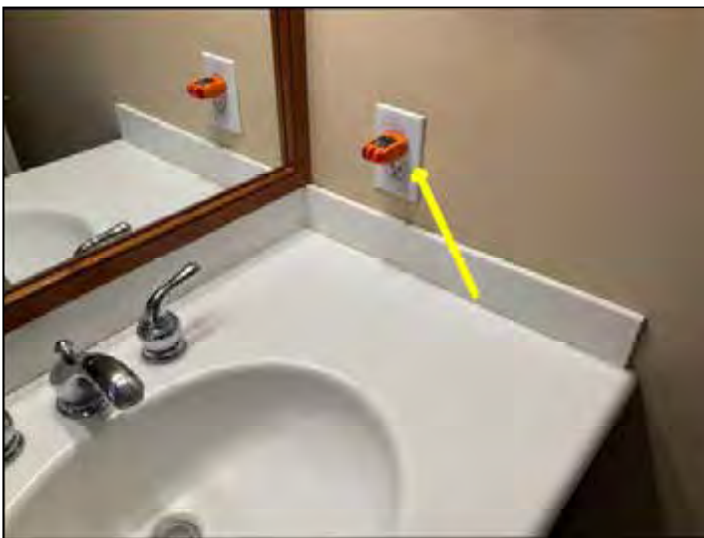
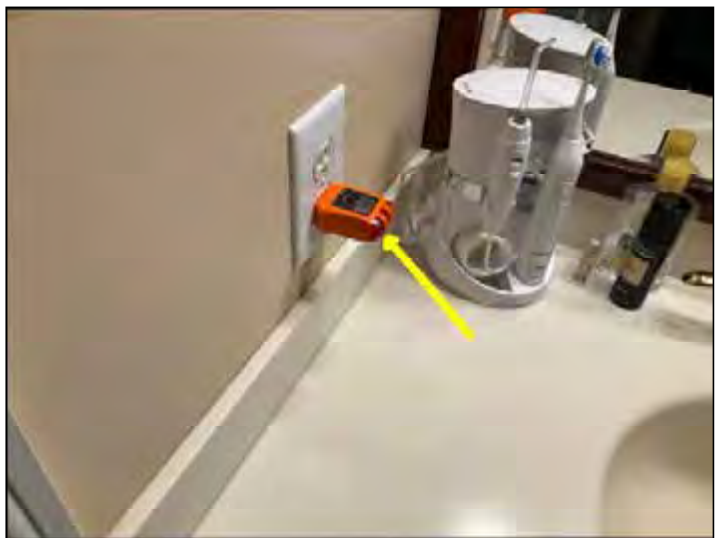
2. GFCI

- GFCI do not have power at the time of inspection, repair. Location:. Left side bathrooms and powder room.

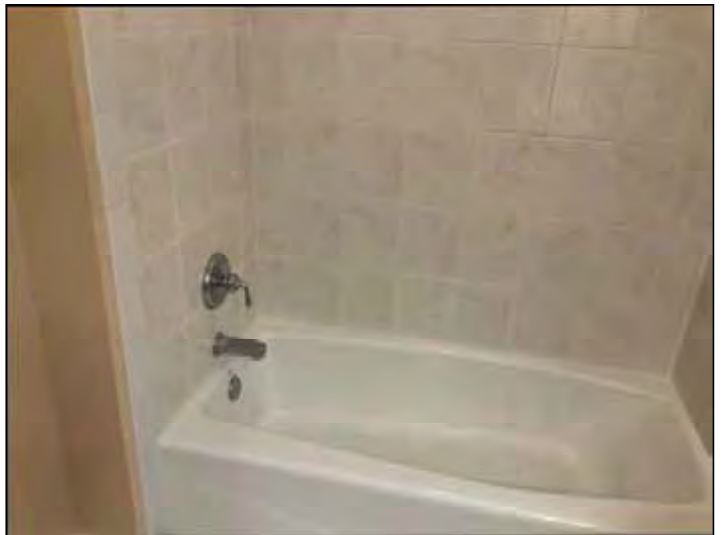
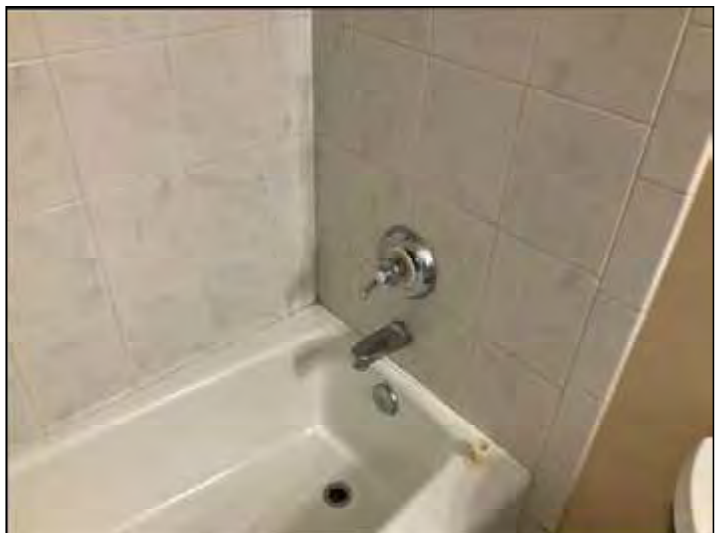
- Ceramic tile noted.
- Fiberglass surround noted.
- Grout missing/deteriorated, repair. Location: Middle front bathroom

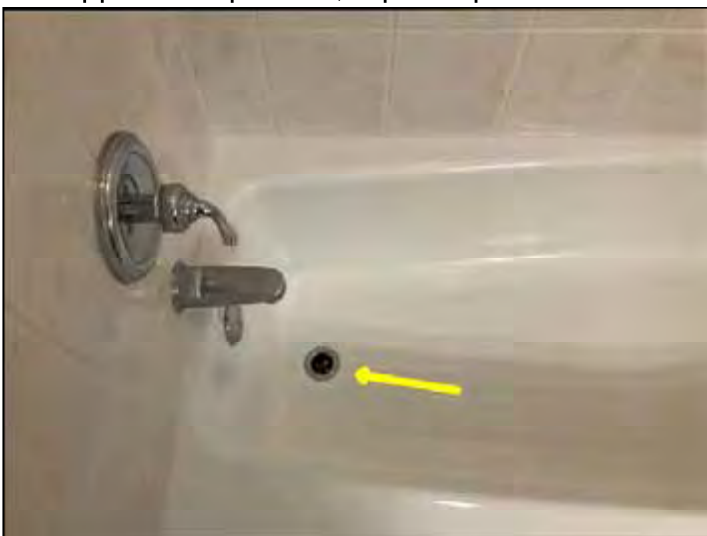
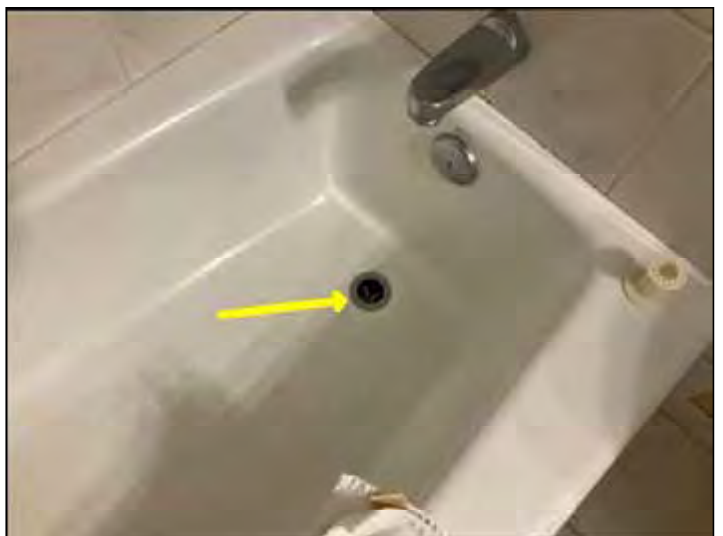
5. Bath Tubs

- Stopper is inoperable, repair/replace. Location: Left rear and middle front bathroom.

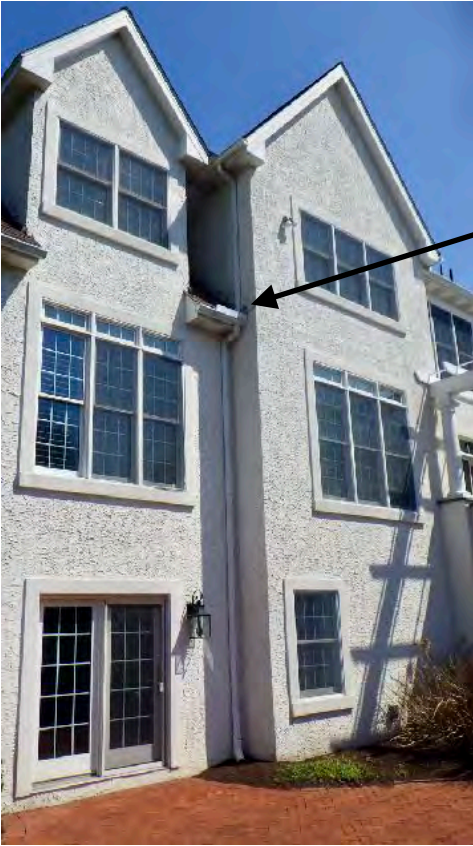
**Reading within specs and sheathing firm.
Common crack in stucco above soffit, allow for
repair.**
