Property Inspection Report

403 Woodale Dr, Kennett Square, PA 19348

Date of Inspection: 3/27/2026 Time: 10:00 AM

Inspector: Patrick Baronsky
License #256972

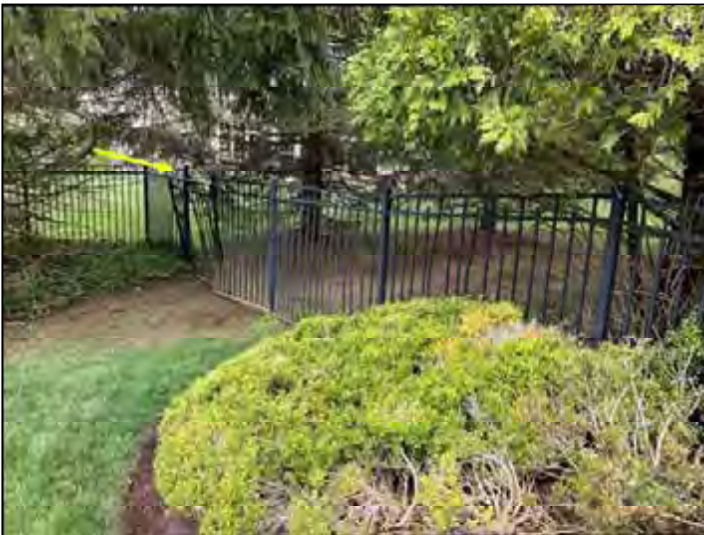
2. Gate Condition

- Fences and gates are NOT INCLUDED as part of a home inspection. Recommend confirming that all fences and gates are in serviceable condition before the settlement.
- Gate hardware missing or damaged gate will not secure, repair.

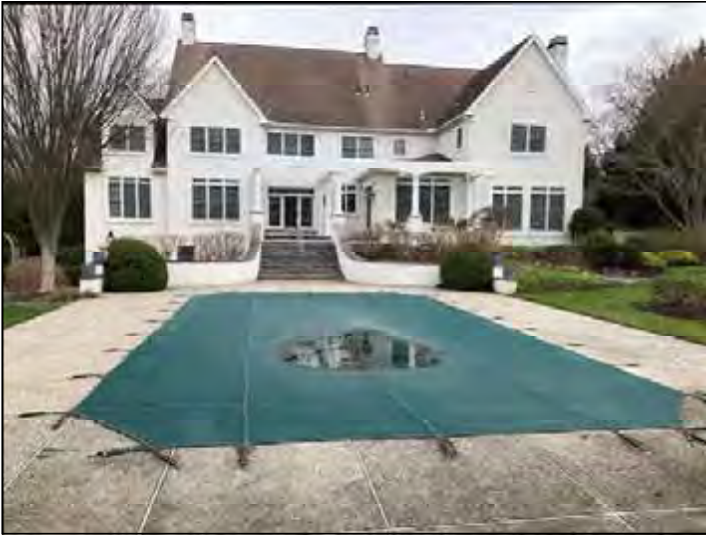
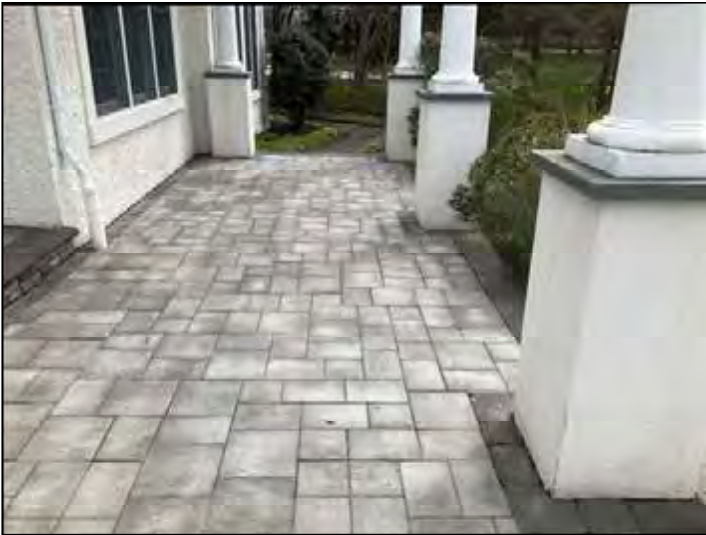
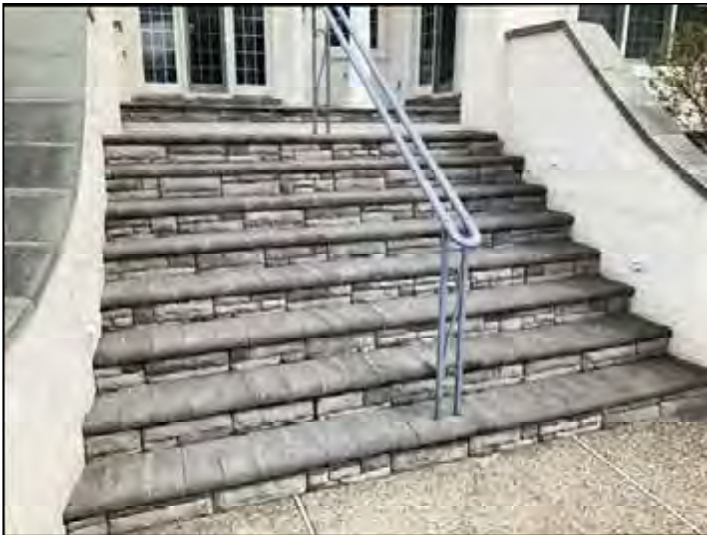
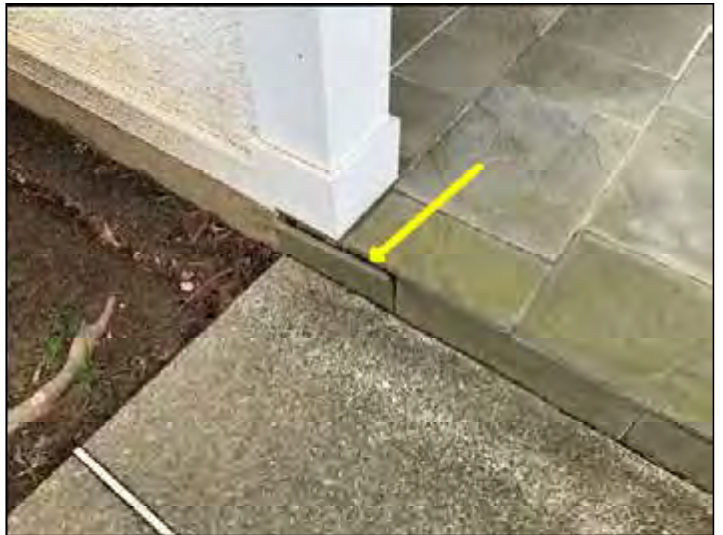
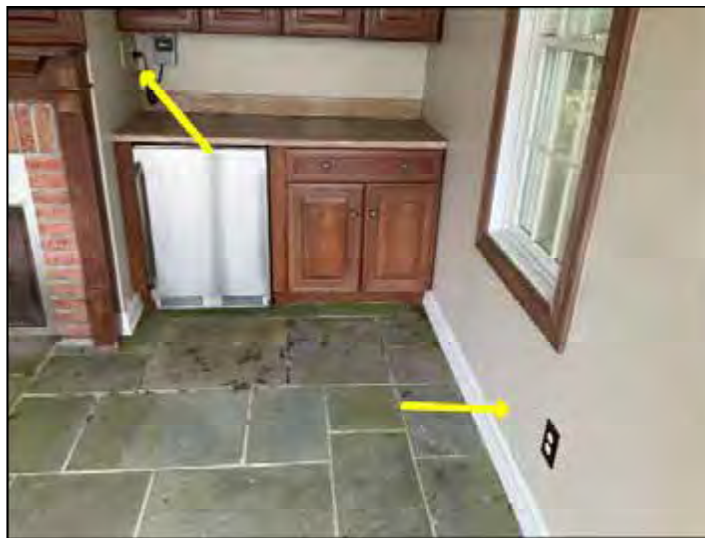
3. Patio

- Pavers damaged/deteriorated, recommend repair.
- Exterior outlets are not protected by a GFCI, recommend repair.

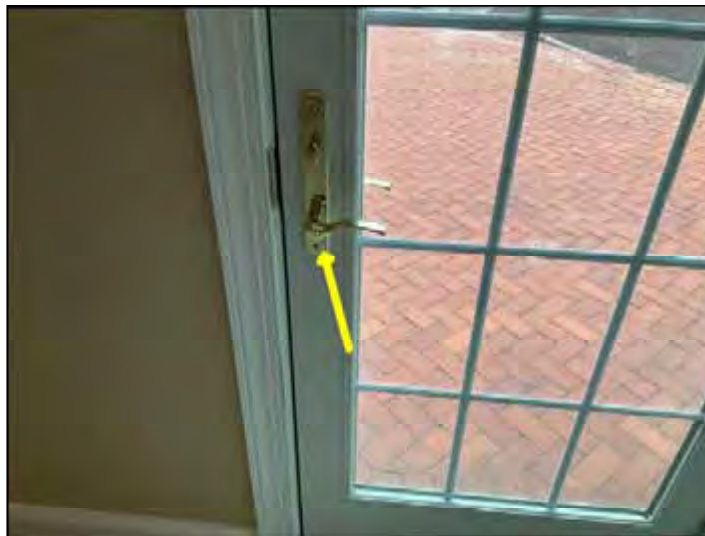
- **Patio door handle set screw loose, repair. Location: Upper and lower doors.**

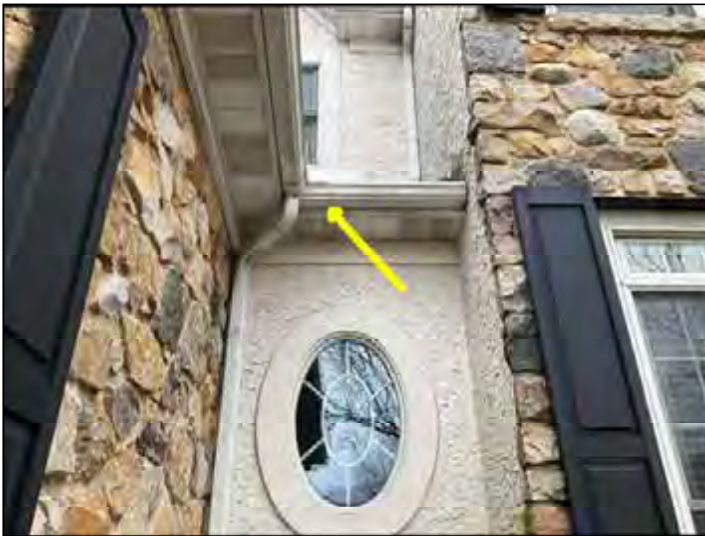
2. Gutter

- Significant amounts of debris evident in gutters, recommend cleaning.

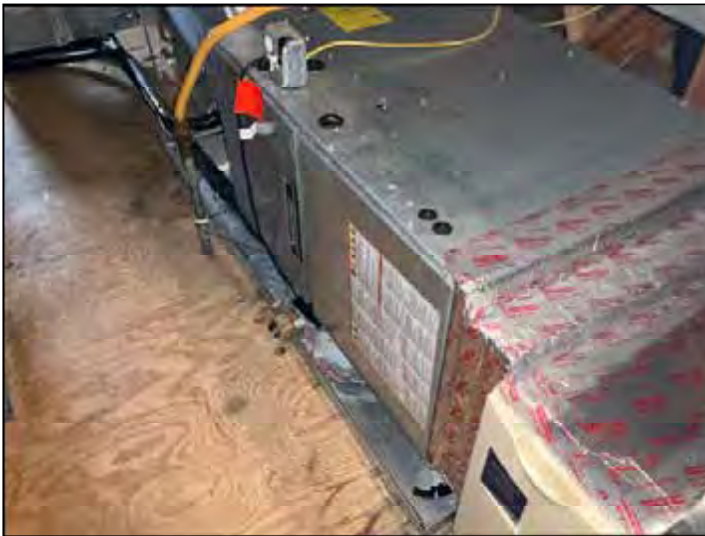
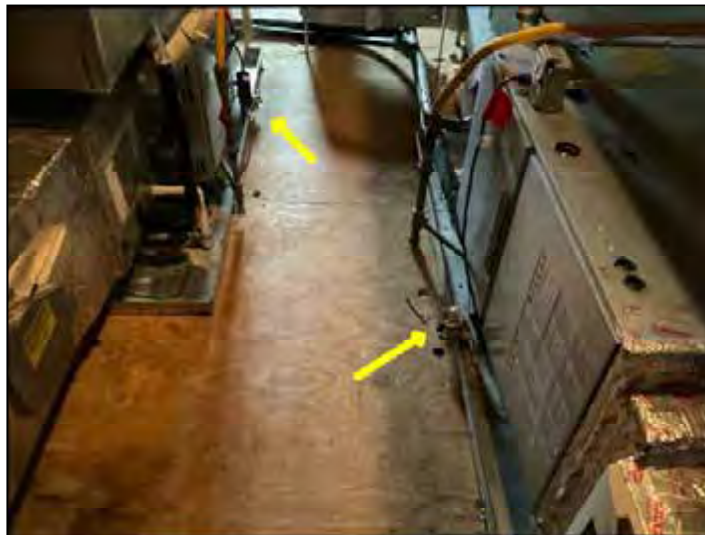
1. Condition

- Estimated/Reported Age 10 Years Life Expectancy 25-30 Years Forced Hot Air Gas Per unit
- Air handler/Heating units installed at areas above living space should have tray and drain installed to help in the event of leaks. Note safety cut off switches are unreliable and often fail. Recommend installing drain to the exterior. Location: Both units

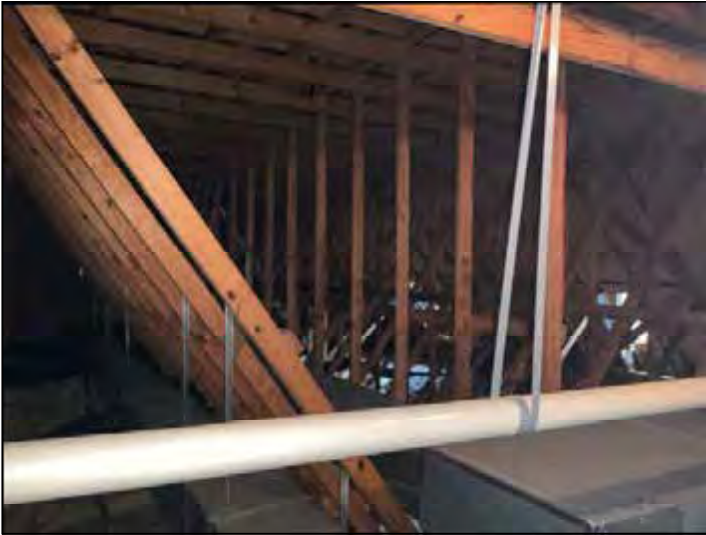
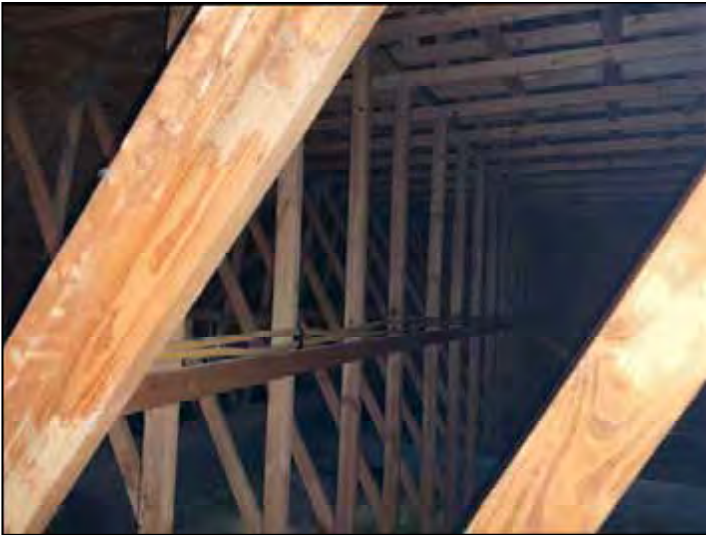
2. Structure

- No concerns at the time of inspection.
- Unable to complete a full inspection due to personal storage/construction
- Evidence of past or present leak at time of the inspection, repair. Location: Center dormer window.

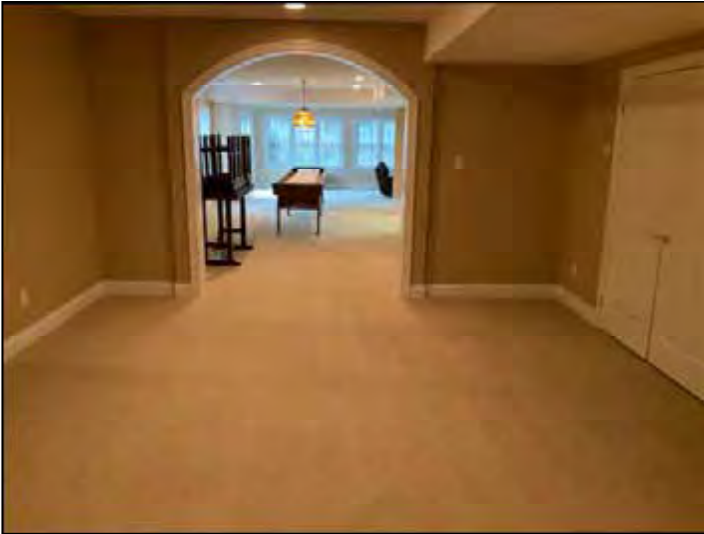
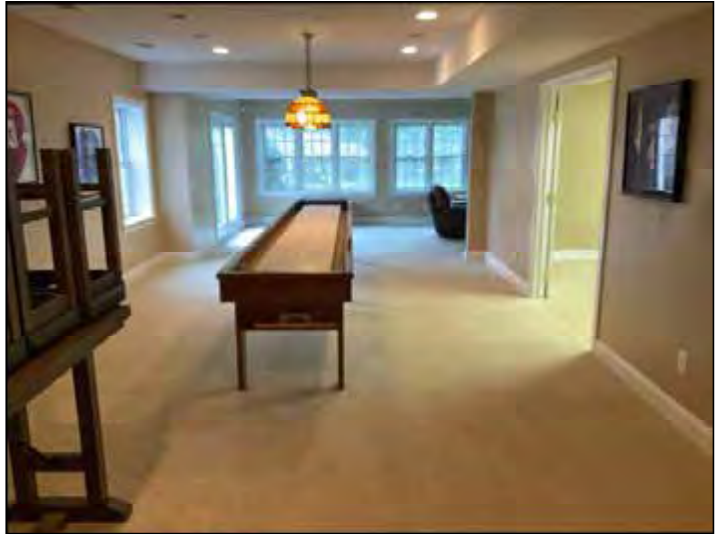
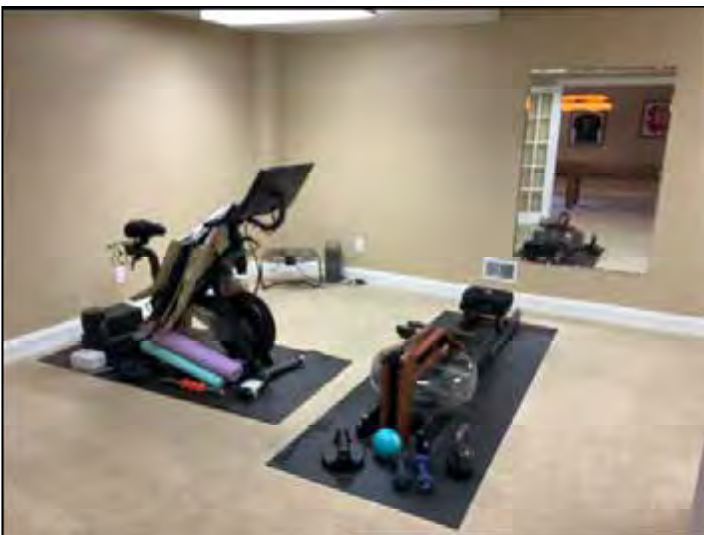
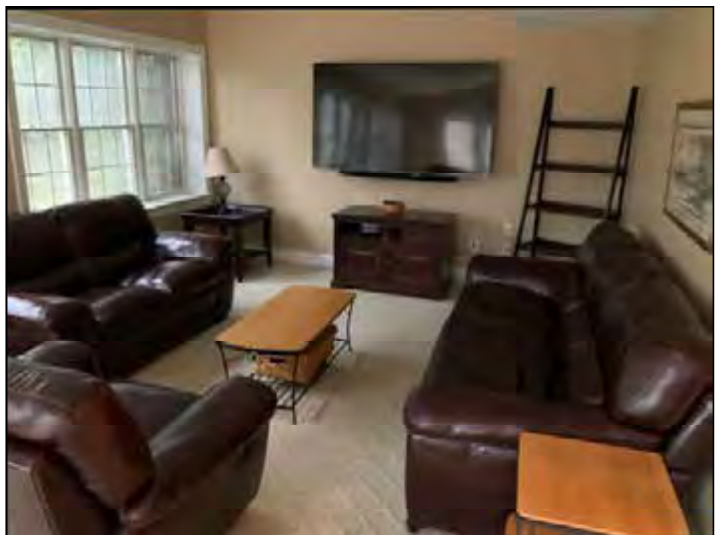
- Unable to complete a full inspection due to personal storage/construction
- Note: The home inspection does not fully determine whether or not the basement has ever had or will ever have water penetration. Extreme conditions, heavy rainfall, (contraction cracks) a rising water table, run-off from the surrounding properties and streets are contributing factors. Ongoing efforts to maintain properly operating gutter systems and grades, periodic testing of drains and sump pumps and ongoing monitoring of conditions surrounding the dwelling are necessary. In some areas it may be necessary to install perimeter drains with sump pits/pumps and even water proofing materials at the foundation walls to control water penetration.

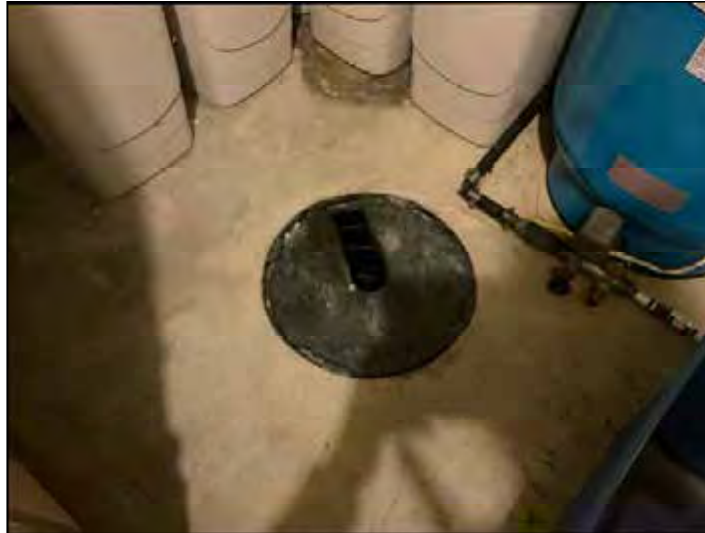
2. Sump Pump

- Sump pump basin present no pump installed at the time of inspection.

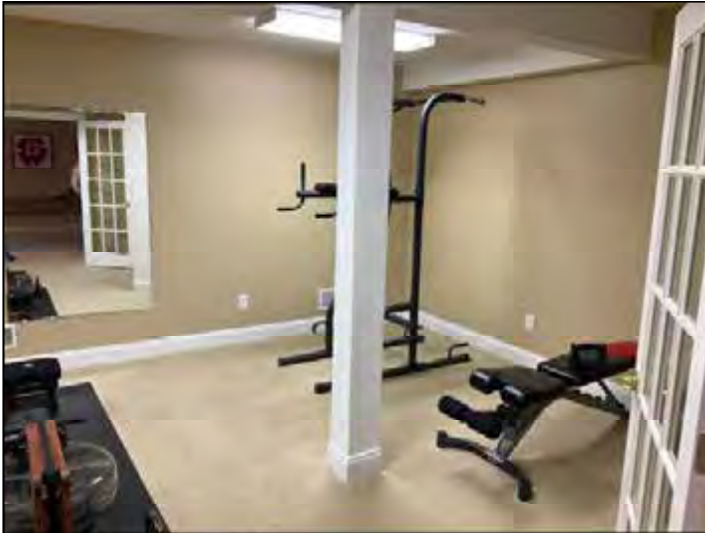
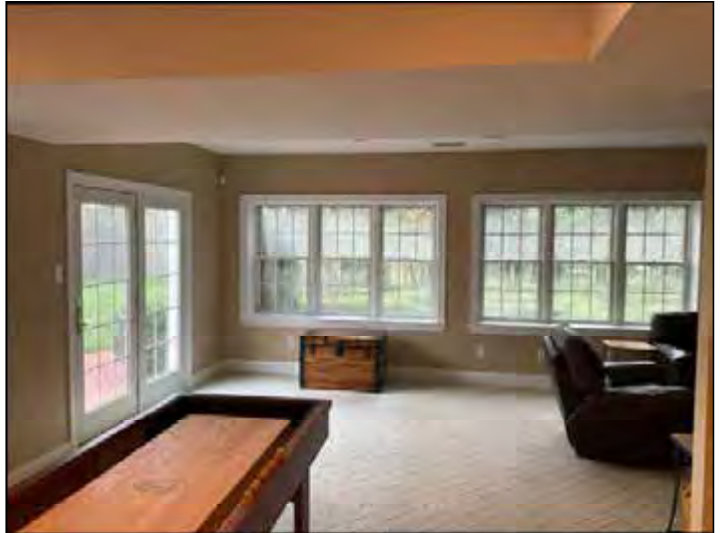
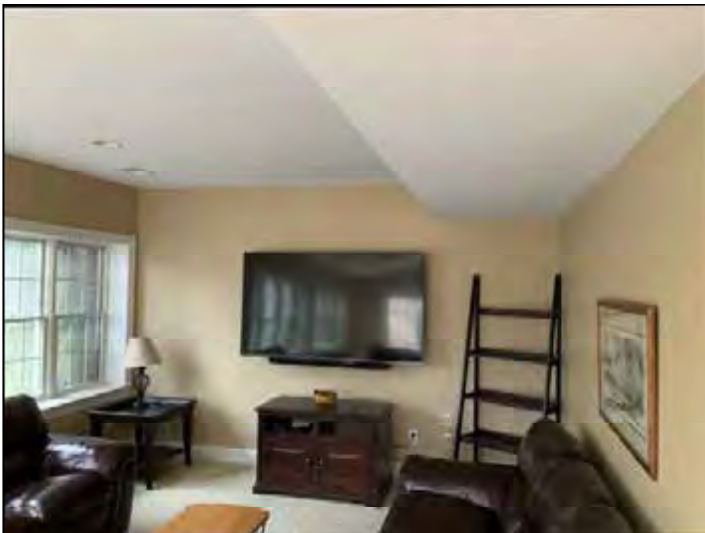
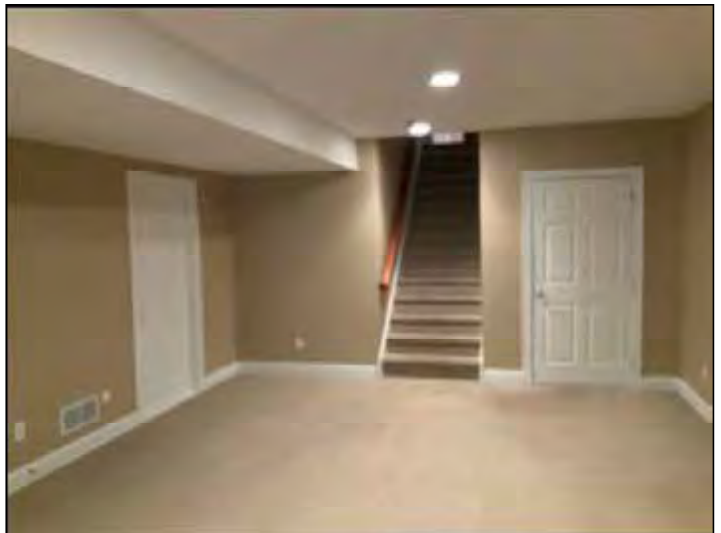
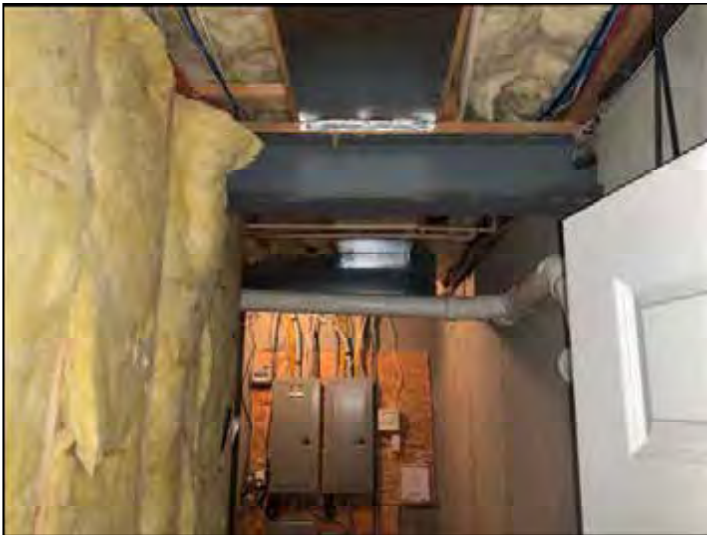
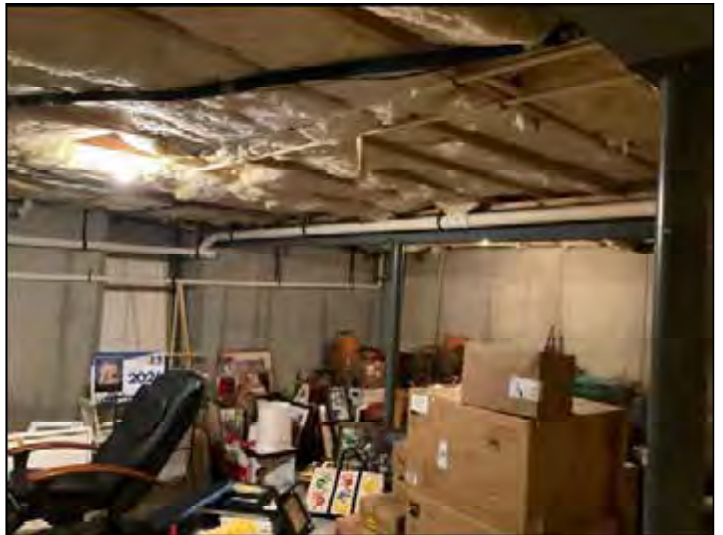
3. Framing

- Unable to complete a full inspection due to personal storage/construction.

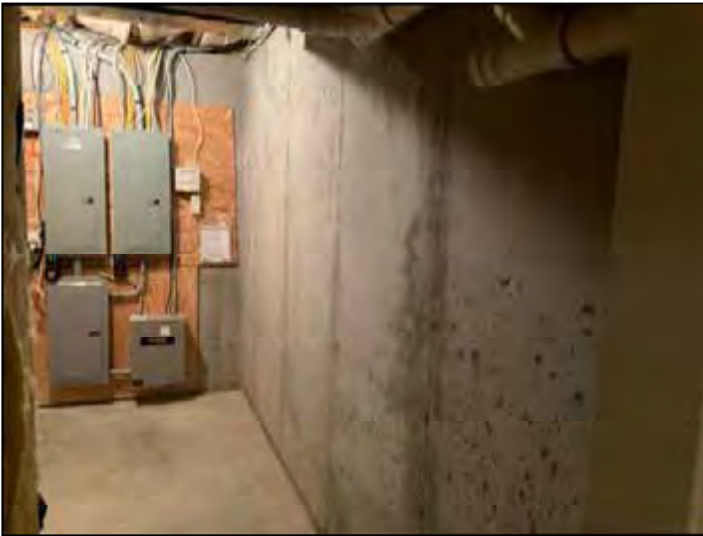
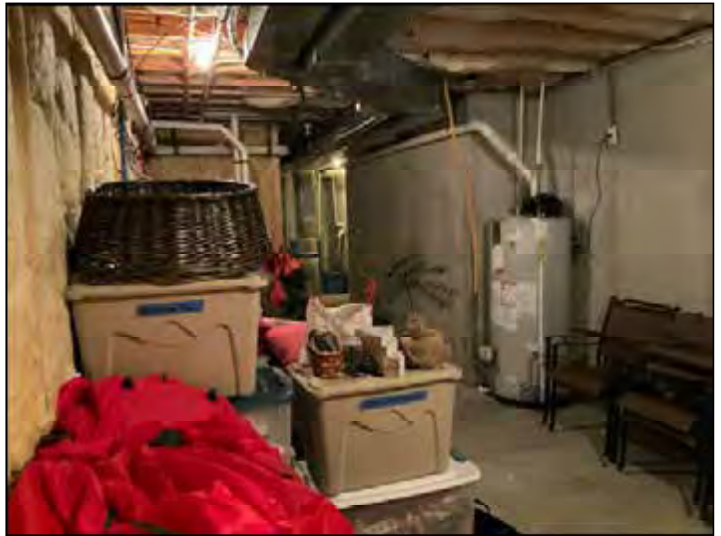
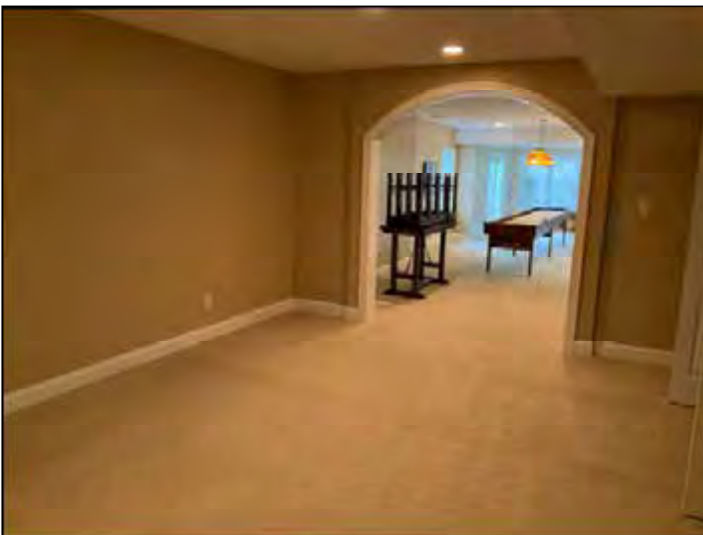
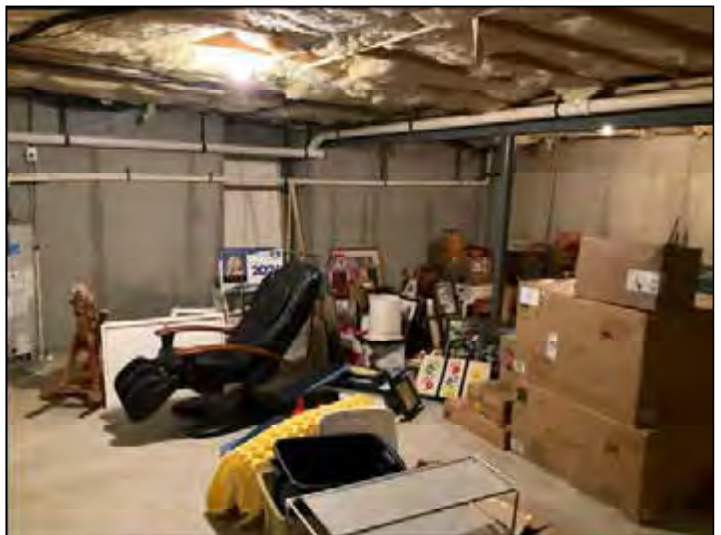
1. Foundation Walls

- No concerns at the time of inspection.
- Appeared serviceable at time of inspection. Structural/footer assembly inaccessible.

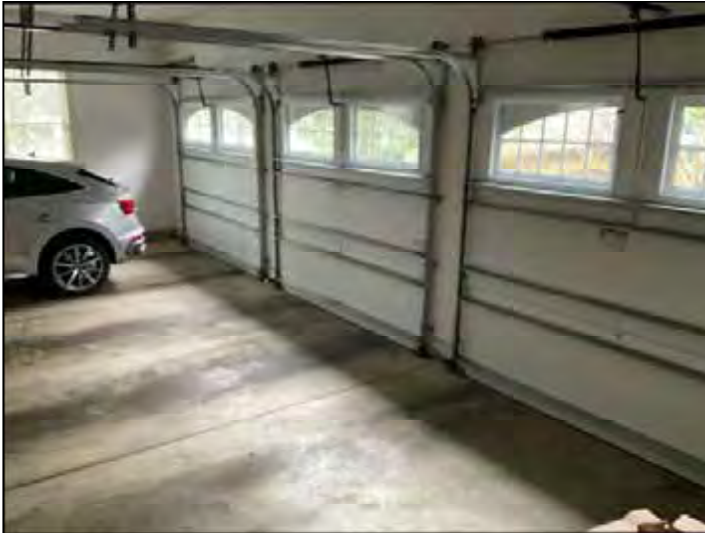
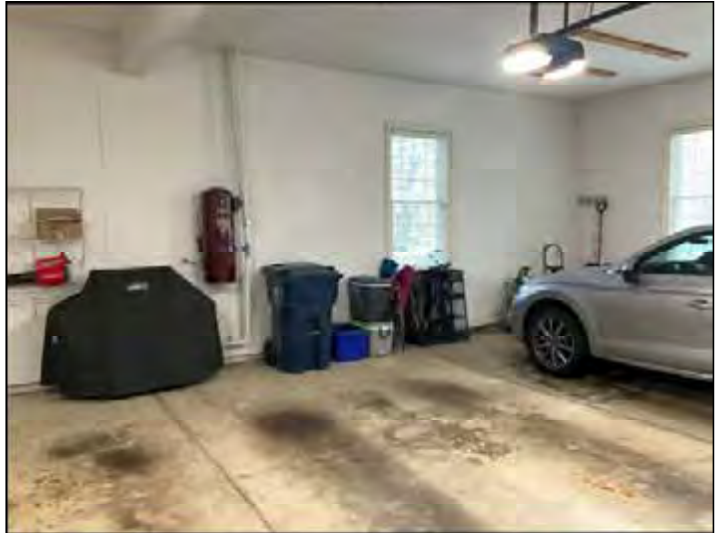
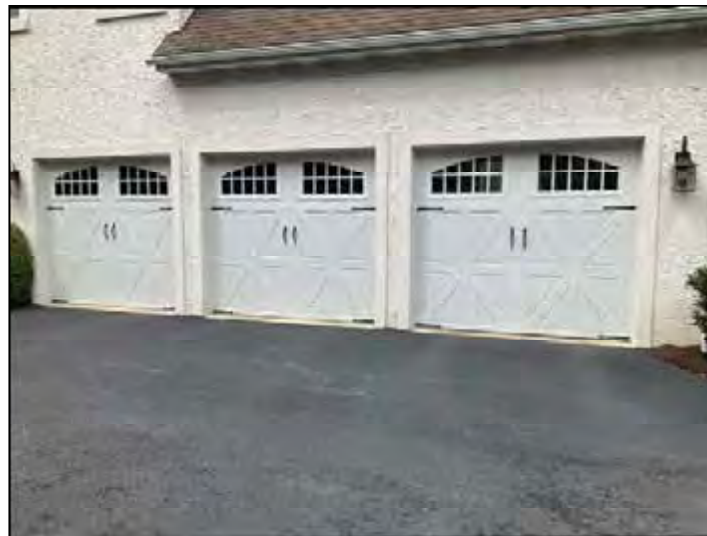
1. Garage Door Condition

- No deficiencies observed.
- Unable to complete a full inspection due to personal storage

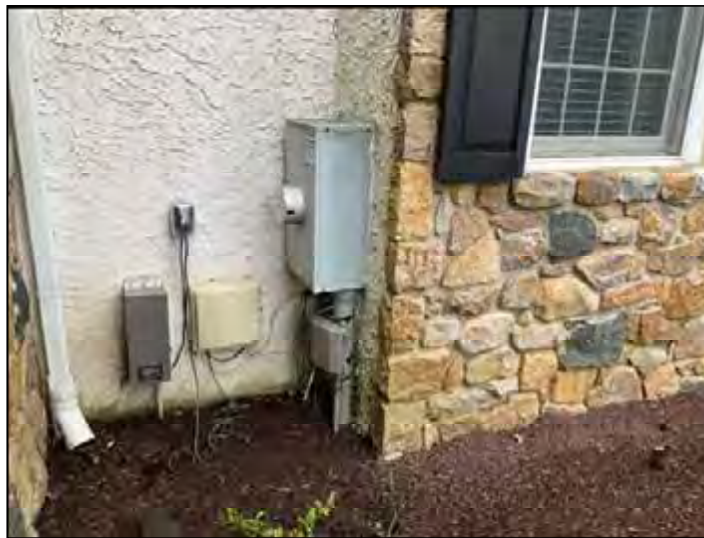
- There is an underground service lateral noted.

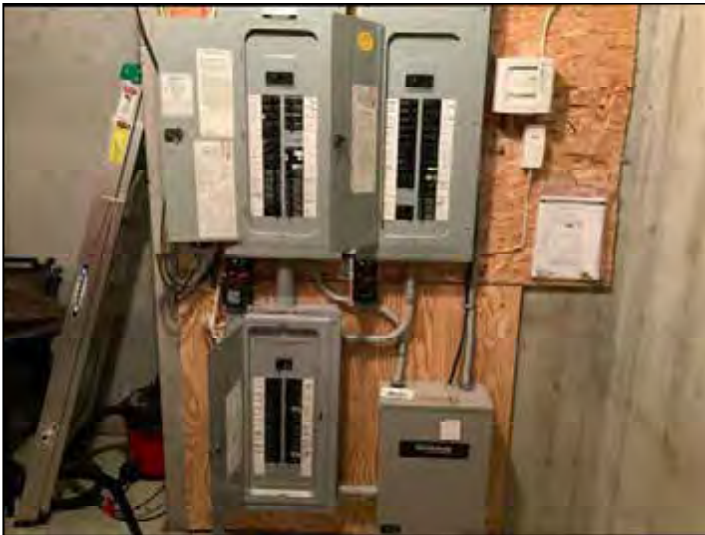
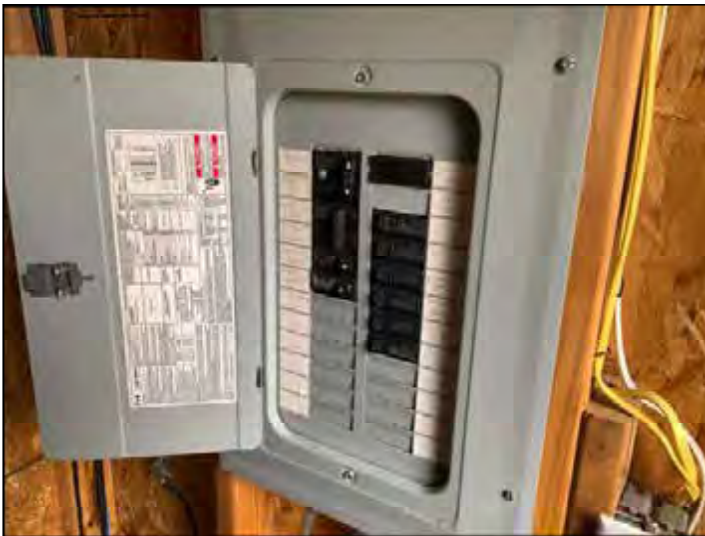
2. Electrical Panel

- 200 Amp Service Noted
- Generator noted during inspection, recommend separating neutrals and grounds on opposite bars to prevent power surge. Location: Main panels.
- We recommend contacting a licensed electrician to evaluate and repair the issues.

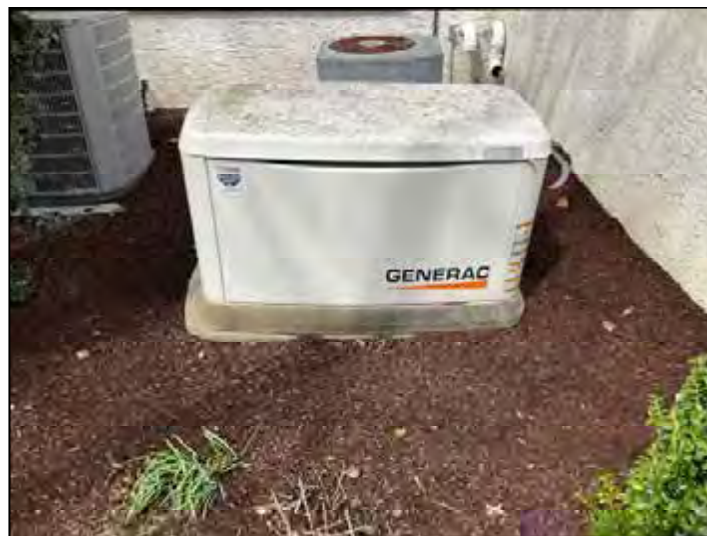
3. Generator

- Generator on site noted, this is a visual inspection only. Recommend qualified generator contractor to inspect operation of generator. Recommend inquiring with owner on maintenance records.

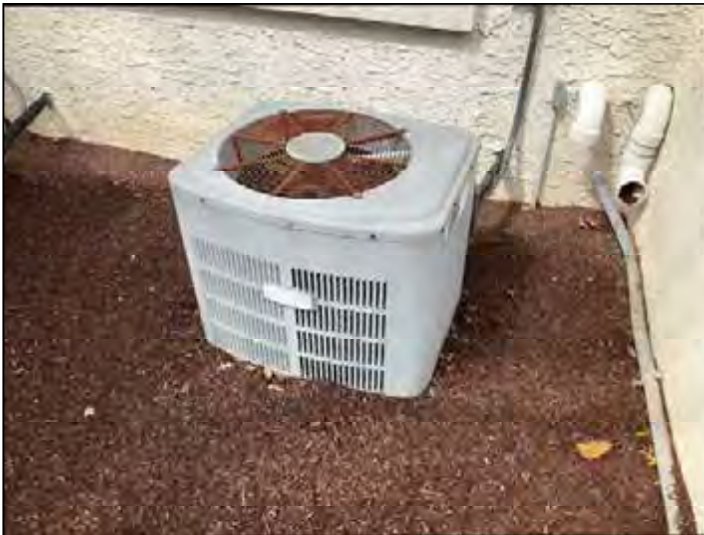
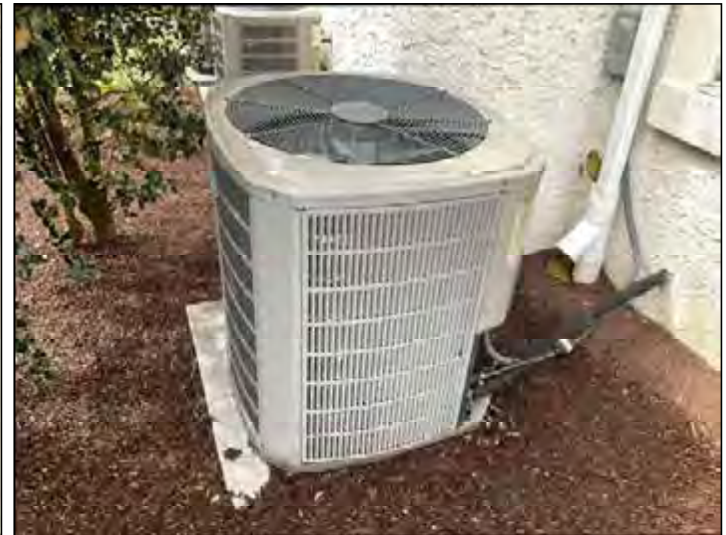
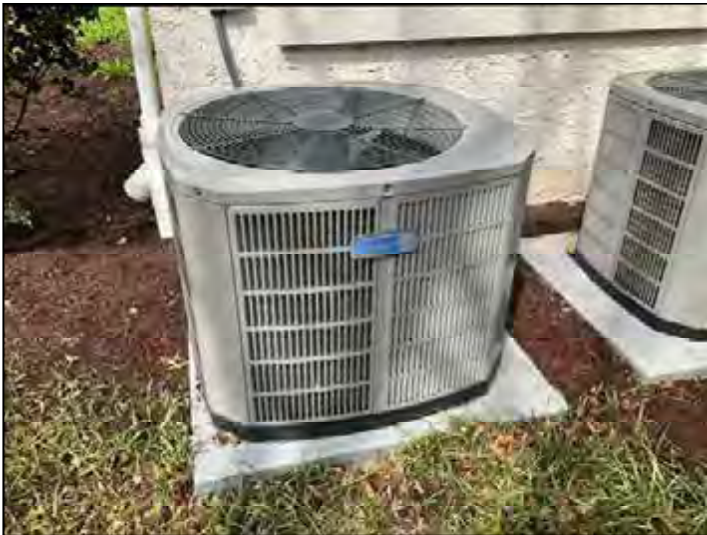
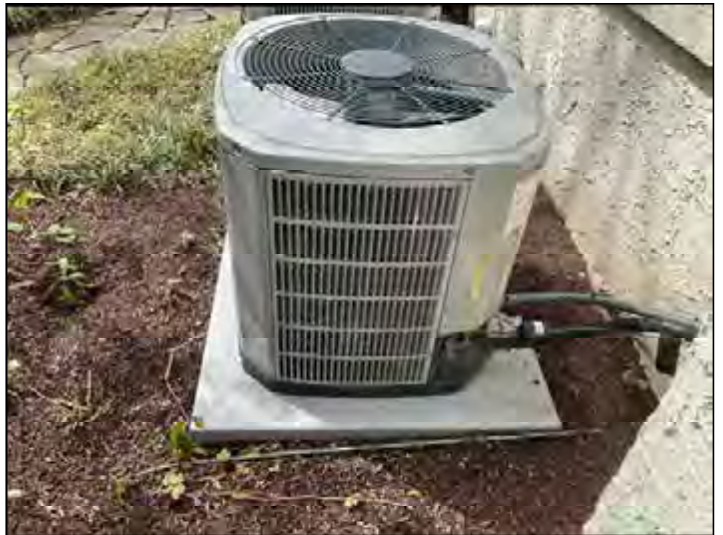
1. AC Compress Condition

- Estimated/Reported Age 24 Years Life Expectancy 15-18 Years
- Approximate size 24,000 BTU's 2 Ton Unit R-22
- Estimated/Reported Age 6 Years Life Expectancy 15-18 Years
- Approximate size 60,000 BTU's 5 Ton Unit R-410A
- Estimated/Reported Age 10 Years Life Expectancy 15-18 Years
- Approximate size 30,000 BTU's 2.5 Ton Unit R-410A
- Estimated/Reported Age 10 Years Life Expectancy 15-18 Years
- Approximate size 42,000 BTU's 3.5 Ton Unit R-410A
- Air Conditioning mounting pads are not level, this may shorten motor life. Recommend leveling the units.
- Not inspected, outside temperature below 65 degrees, Recommend operating/testing unit prior to closing if outside temperatures allows.

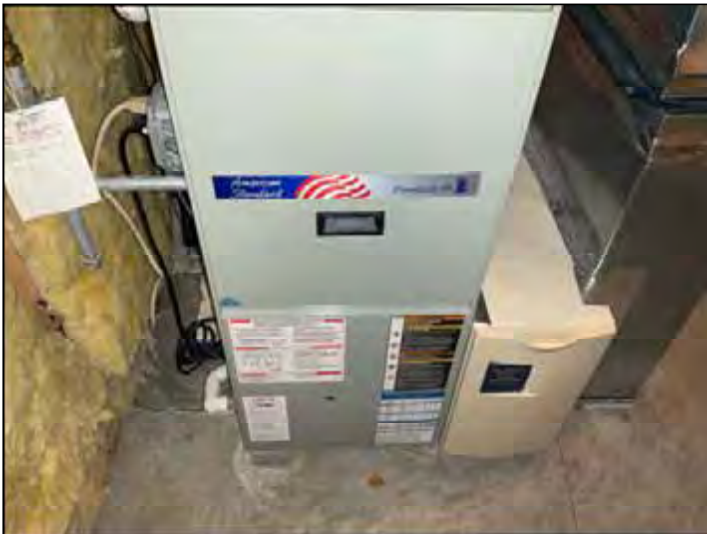
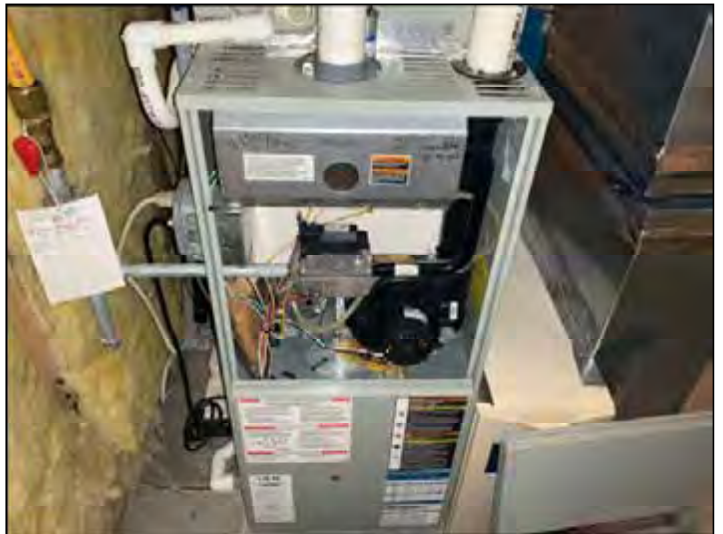
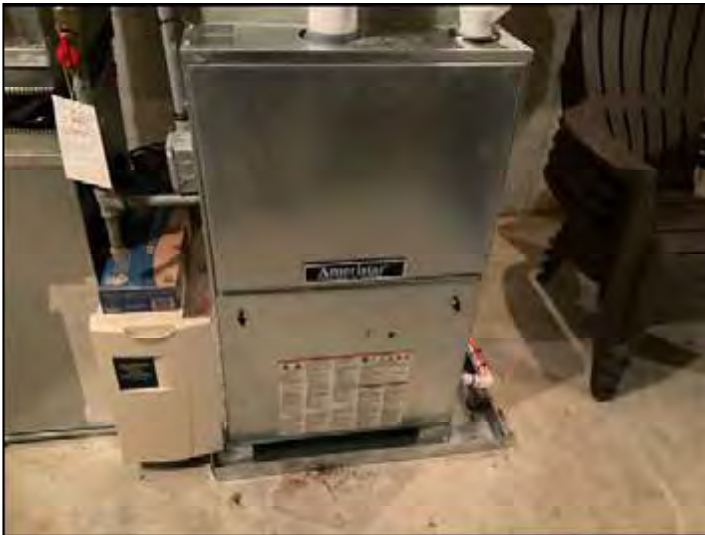
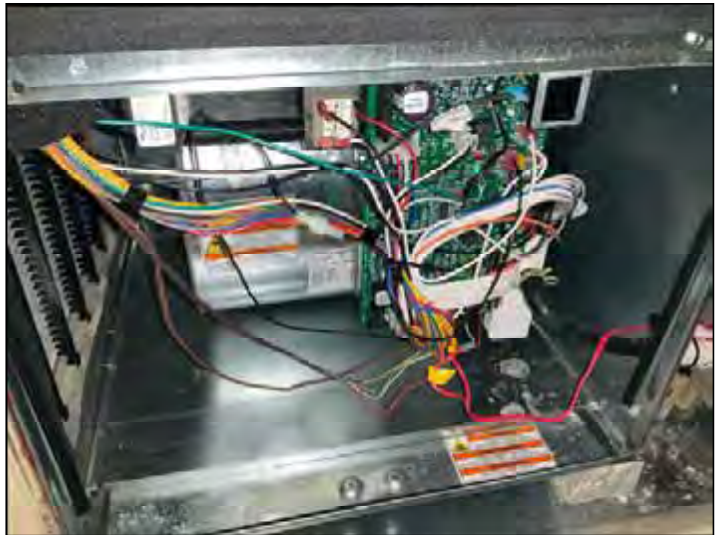
2. Heater Condition

- Estimated/Reported Age 24 Years Life Expectancy 25-30 Years Forced Hot Air Location: Center Front
- Estimated/Reported Age 6 Years Life Expectancy 25-30 Years Forced Hot Air Location: Right Front
- No concerns functional at the time of the inspection.

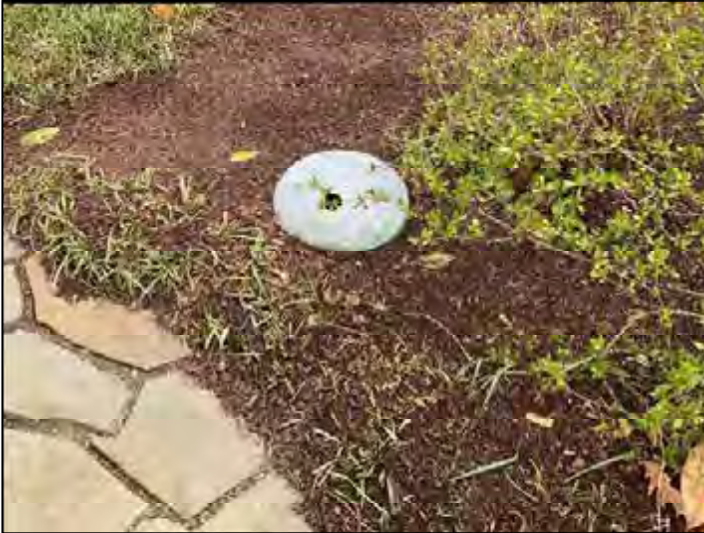
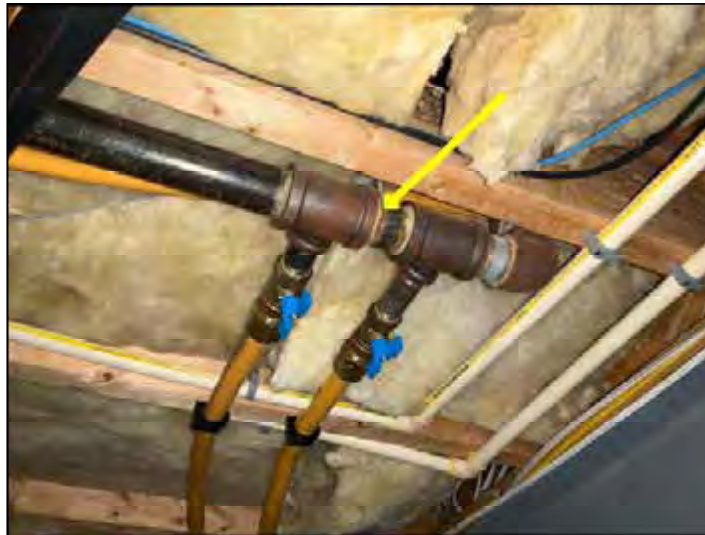
- **Safety Concern:** House equipped with CSST gas supply lines should be bonded and grounded properly. Recommend that you contact a licensed electrician to repair.

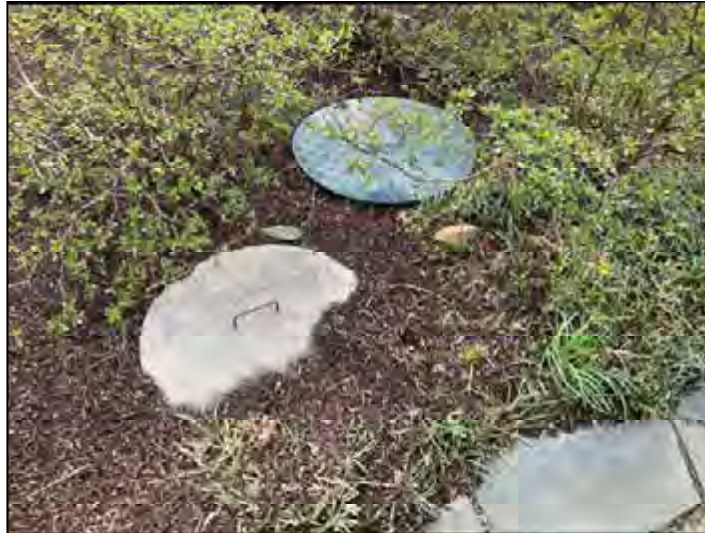
2. Septic Condition

- This inspection is a visible inspection of septic system, recommend licensed septic technician to inspect and certify.

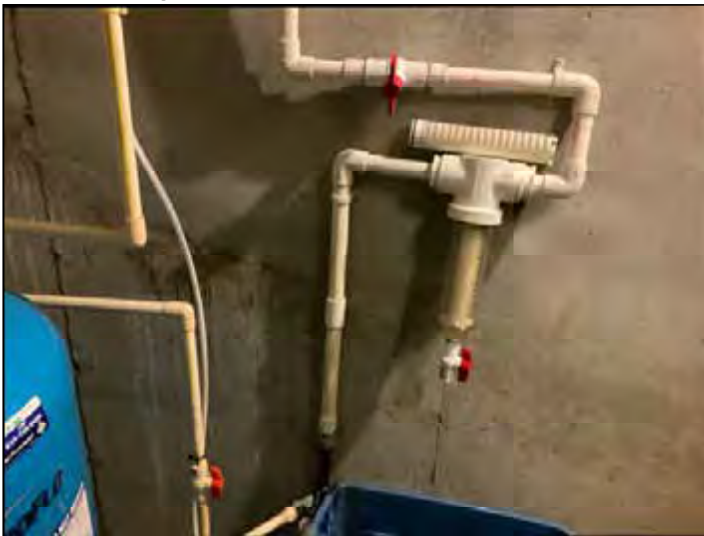
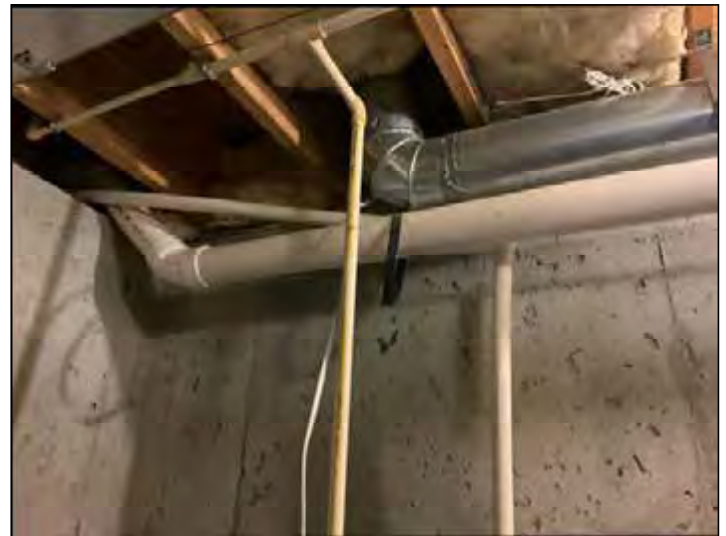
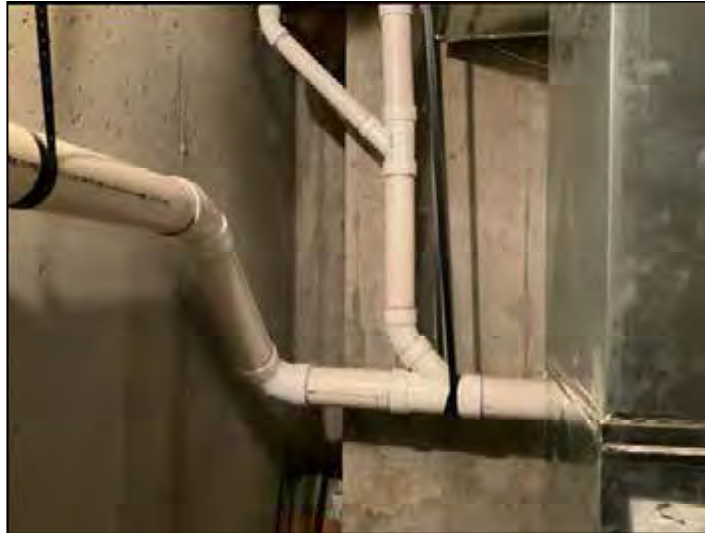
3. Plumbing

• Inspection of all areas of the water supply pipes was not possible due to limited access/finished walls and ceilings to check for defects such as, but not limited too:leaks, corrosion, improper workmanship, and damage.

• Inspection of all areas of the drain pipes was not possible due to limited access/finished walls and ceilings to check for defects such as, but not limited too:leaks, corrosion, improper workmanship, and damage.

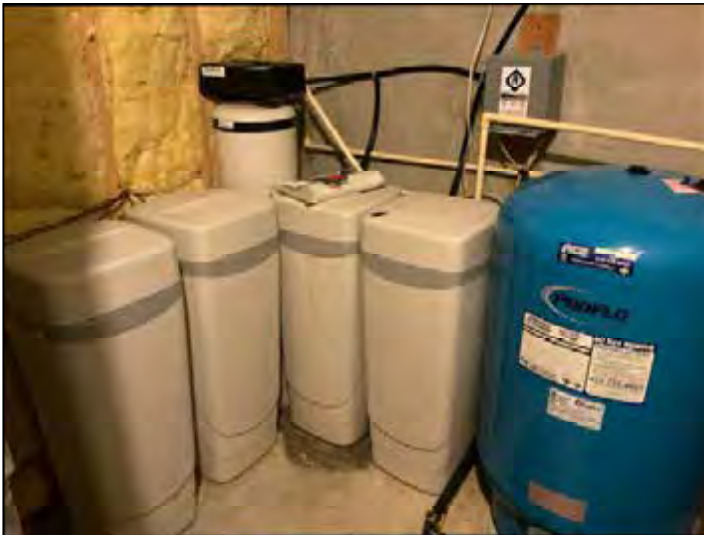
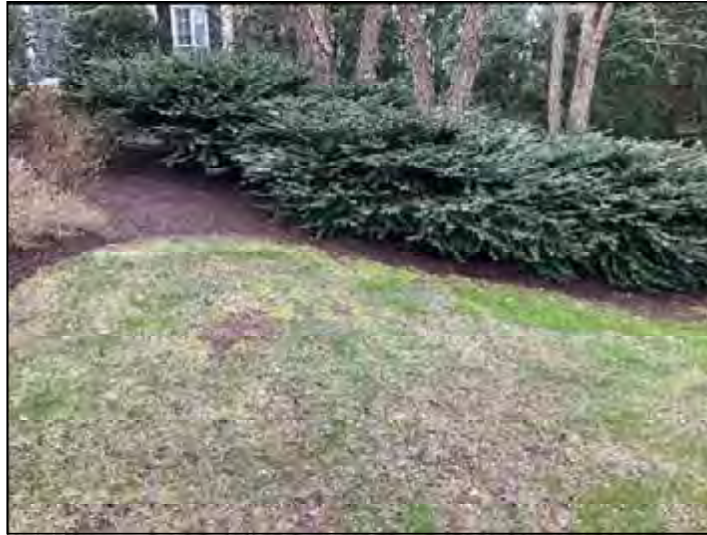
4. Well

- This inspection is a visible inspection of well controls, recommend licensed well technician to inspect and certify.
- Open junction boxes were observed, which is a safety concern. Recommend installing proper covers, as needed, for safety.

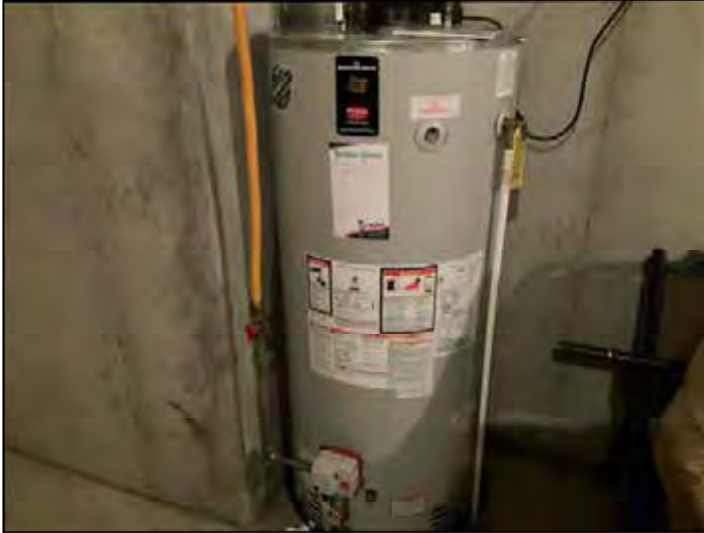
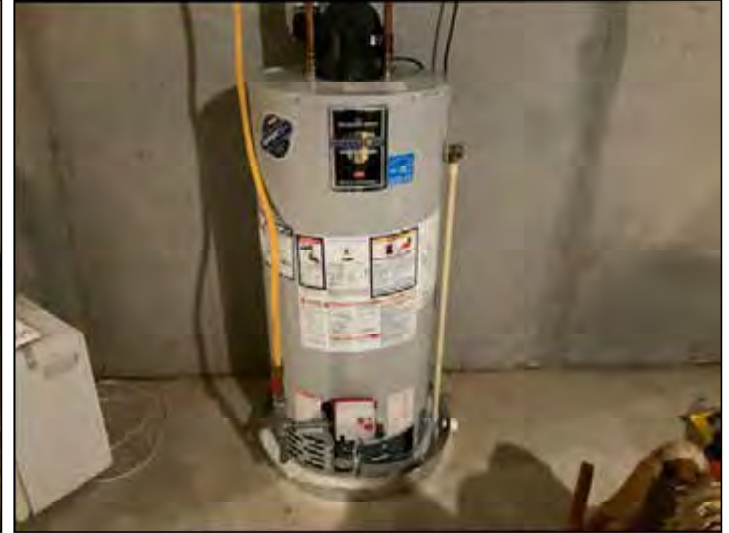
1. Water Heater Condition

- Estimated/Reported Age 6 Years Life Expectancy 12-16 Years Gas Fired 75 Gallon
- Estimated/Reported Age 4 Years Life Expectancy 12-16 Years 50 Gallon
- Tank appears to be in satisfactory condition -- no concerns.

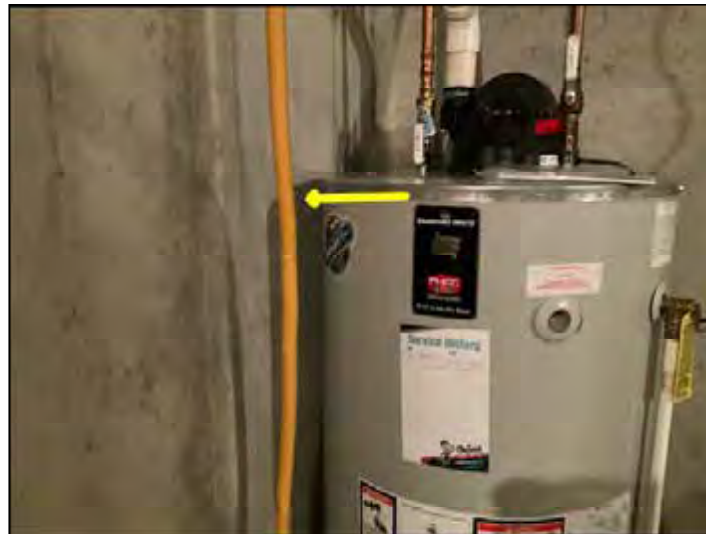
- Unsecured gas line was observed safety concern, repair.

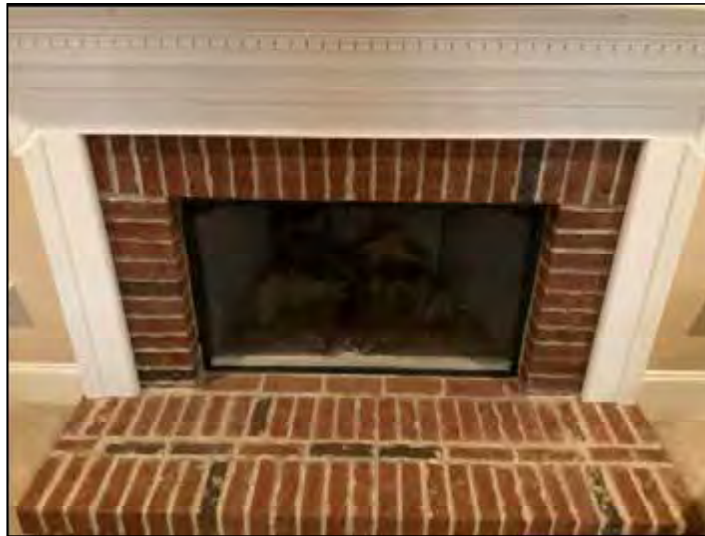
- Visual inspection only have a fireplace professional evaluate and repair any issues found before attempting to use fireplace.

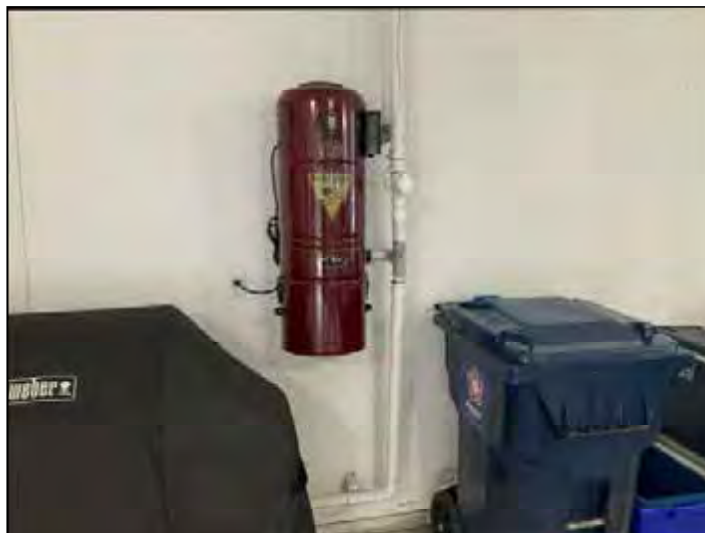
2. Intercom

- Note internal vacuum system not part of home inspection. Inquire with owner on operation prior to settlement.
