Property Inspection Report

403 Woodale Dr, Kennett Square, PA 19348

Date of Inspection: 3/27/2026 Time: 10:00 AM

Inspector: Patrick Baronsky
License #256972

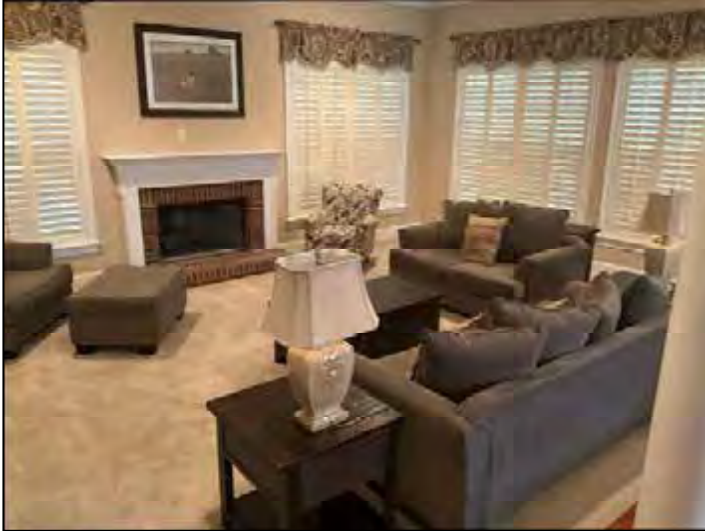
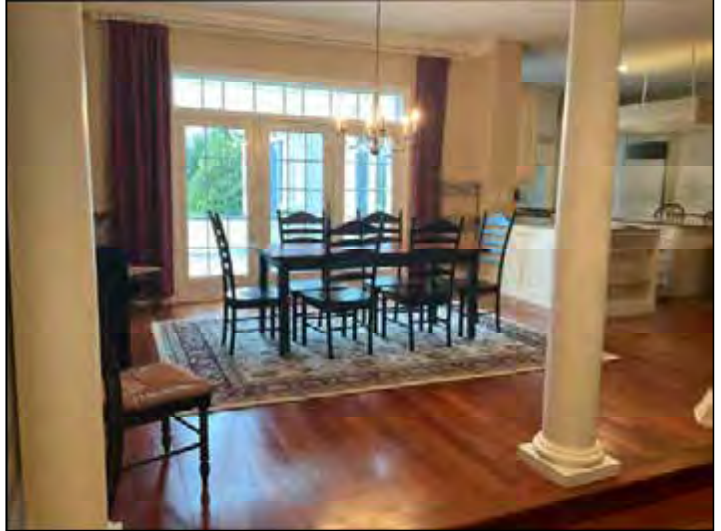
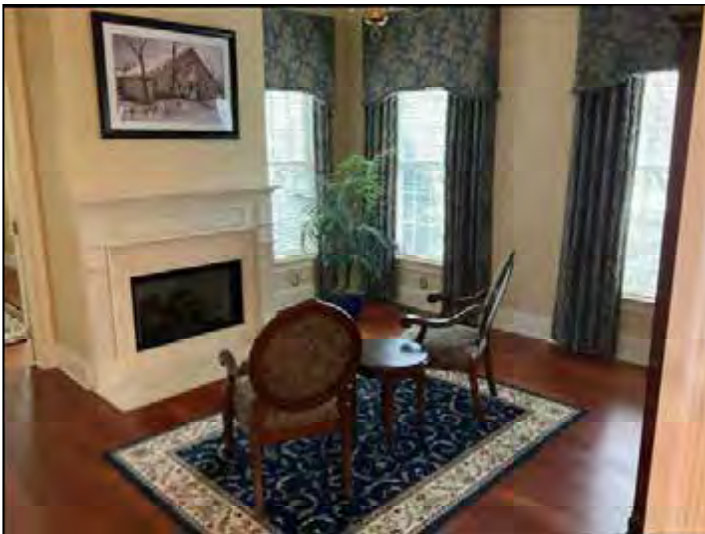
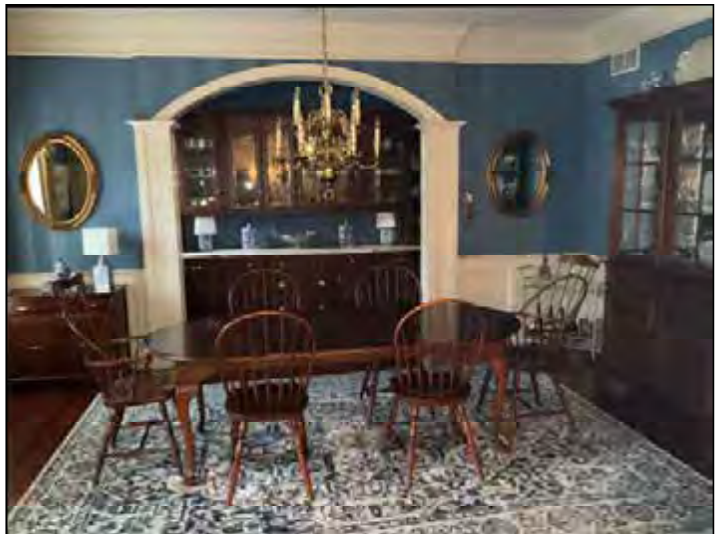
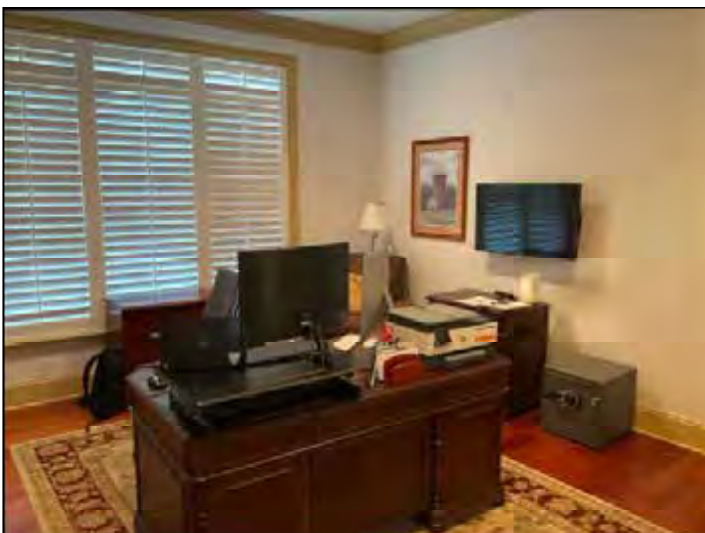
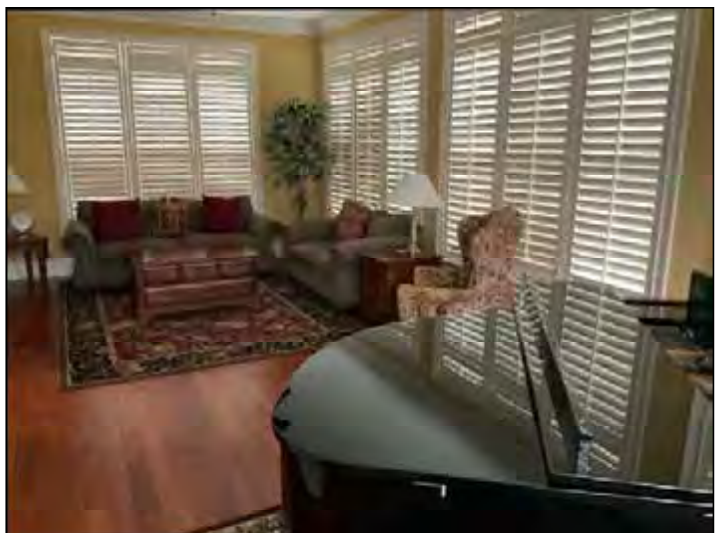
3. Wall Condition

- Inspection of smoke detectors are not a part of the home inspection due to specialize equipment needed to test. Note pushing the button only indicates the button is working. Recommend updated detectors and installing carbon monoxide detectors as needed.

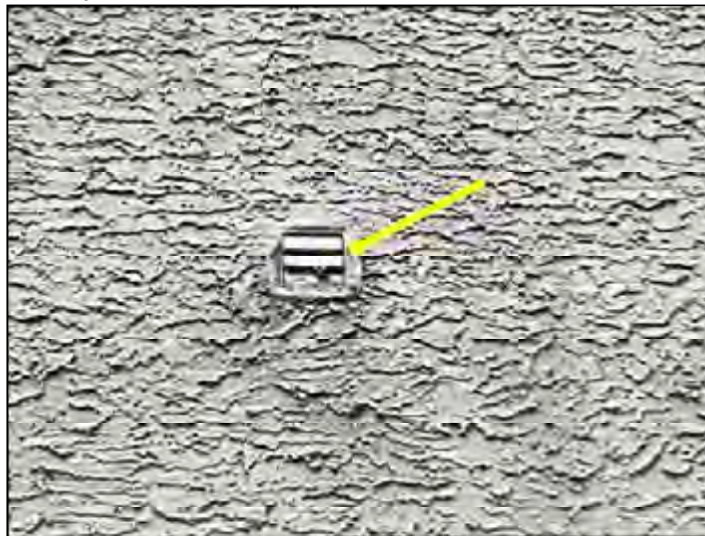
- The dryer vent is clogged, repair.

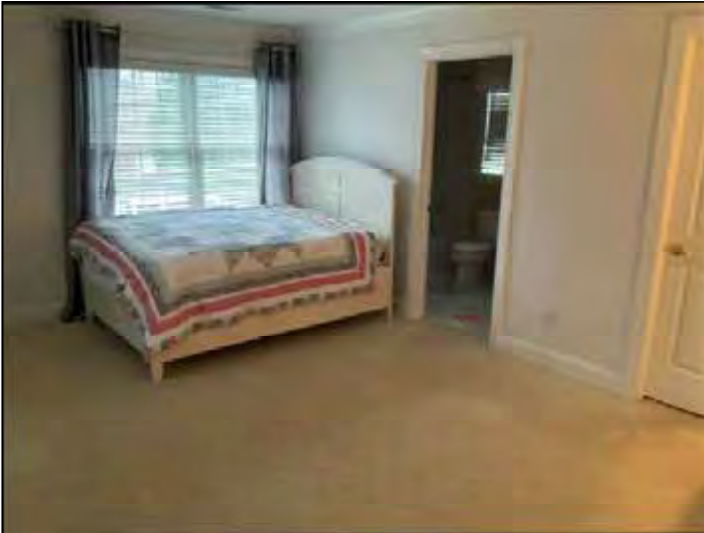
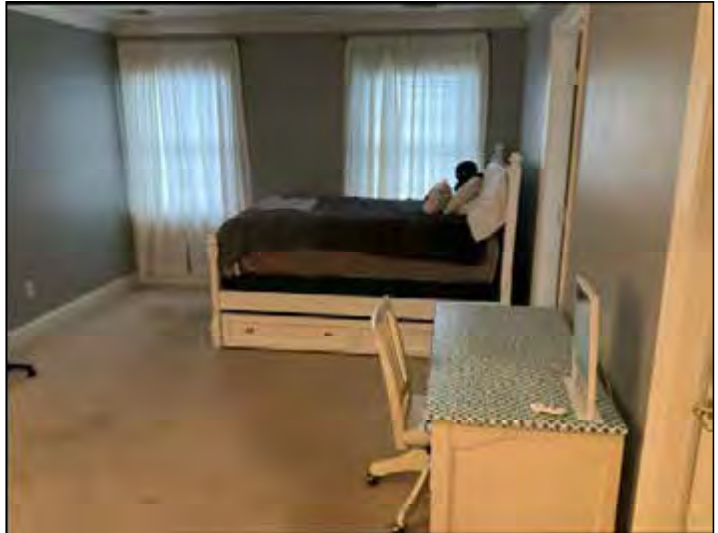
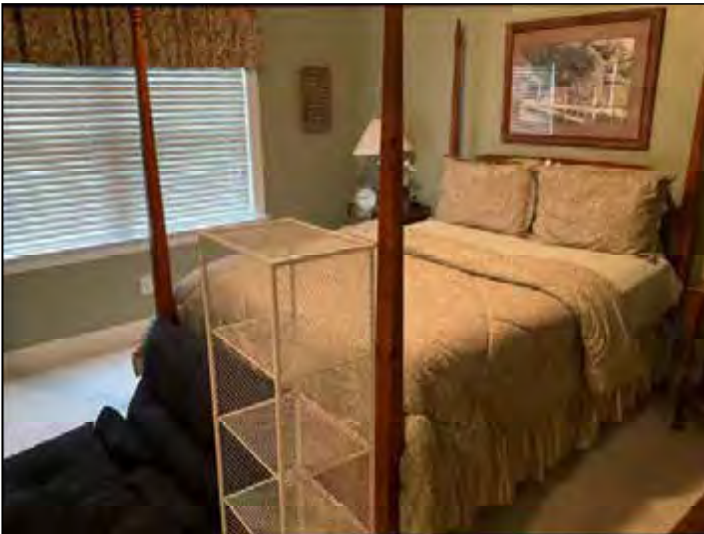
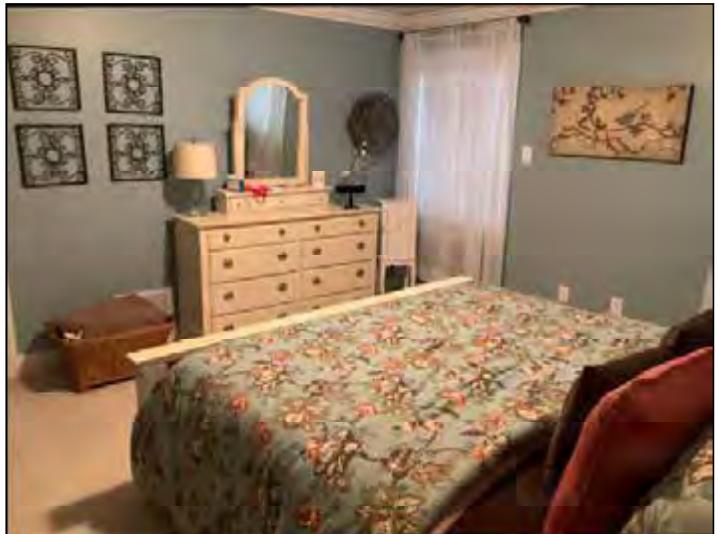
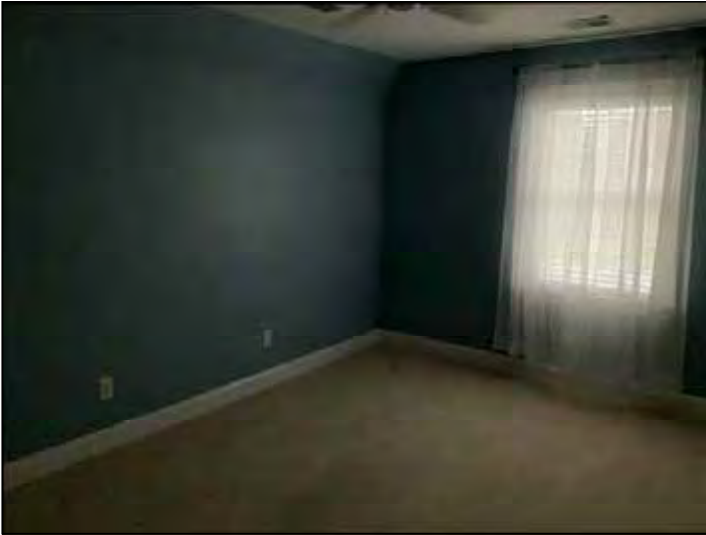
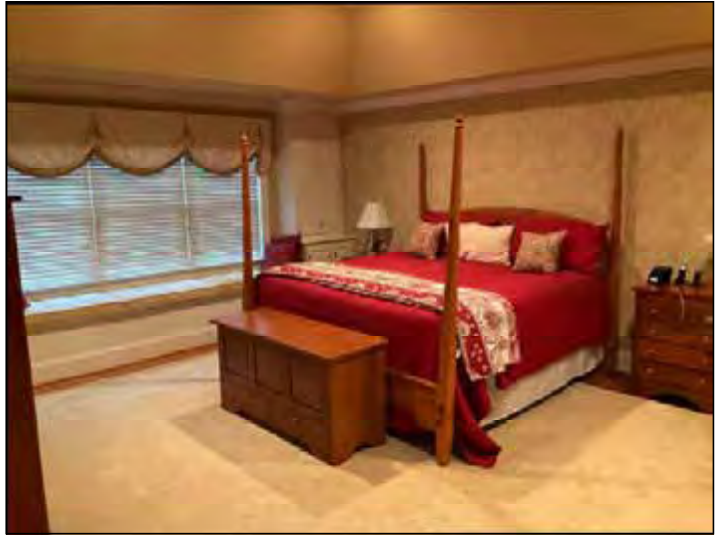
1. Wall Condition

- Inspection of smoke detectors are not a part of the home inspection due to specialize equipment needed to test. Note pushing the button only indicates the button is working. Recommend updated detectors and installing carbon monoxide detectors as needed.

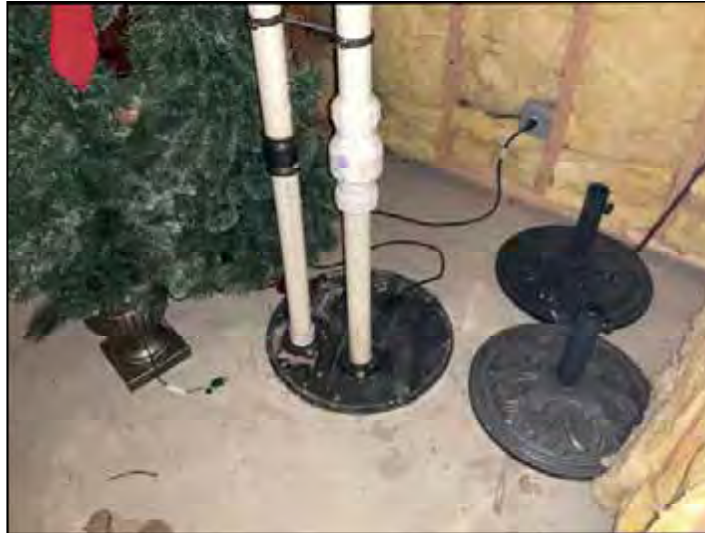
- Sewage pump noted during inspection, tested and found operational at the time of inspection.

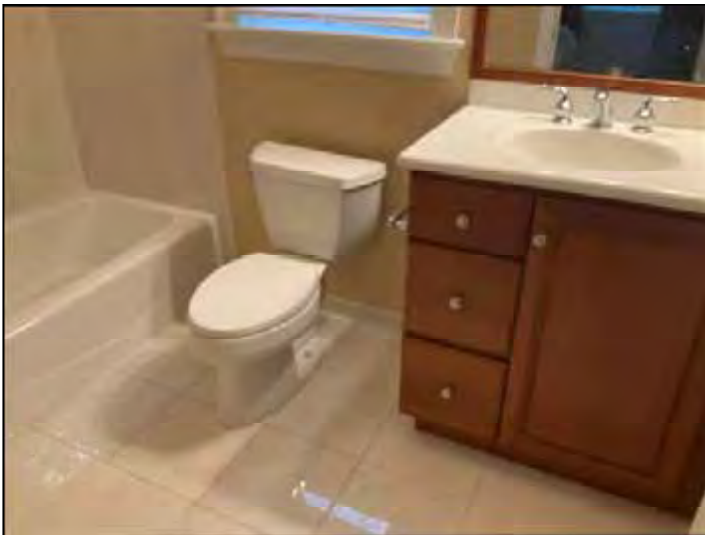
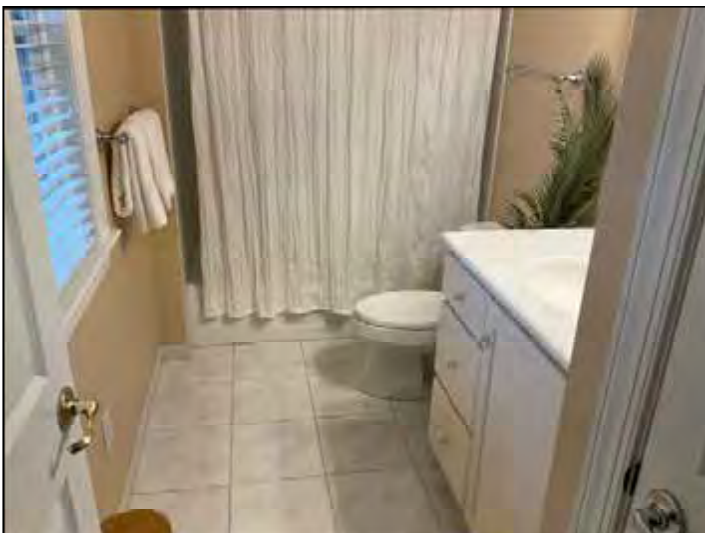
4. Shower Walls

- Ceramic tile noted.
- Fiberglass surround noted.
- Grout missing/deteriorated, repair. Location: Middle front bathroom

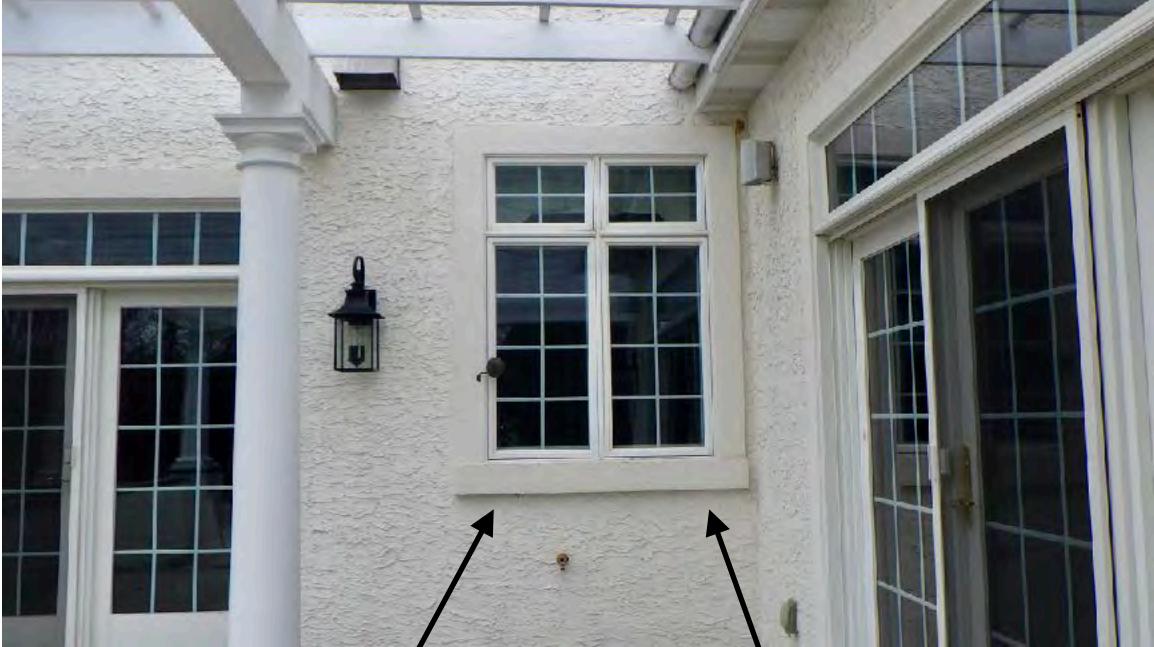
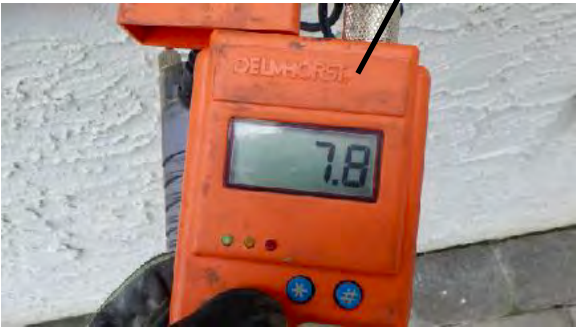
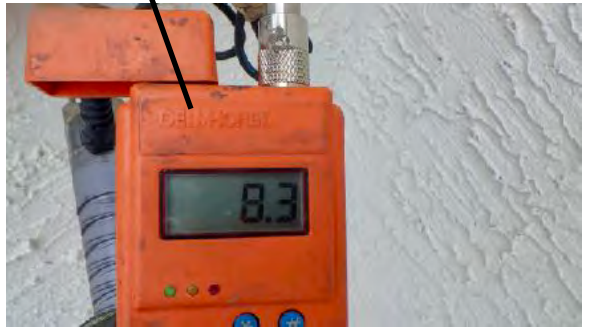
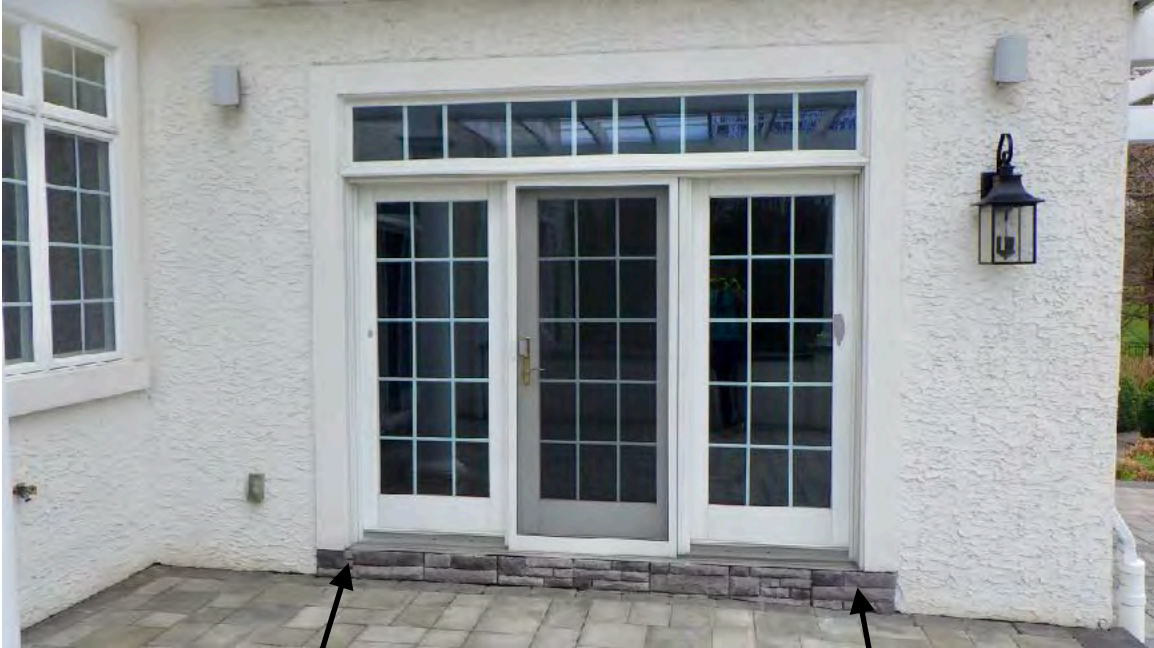
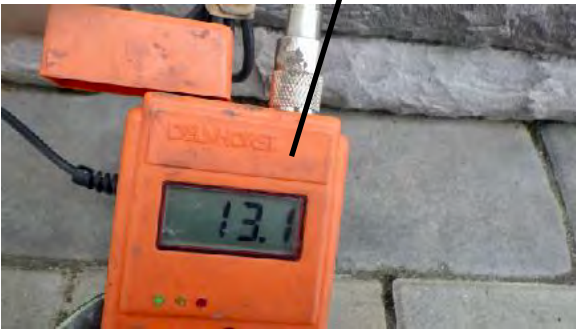
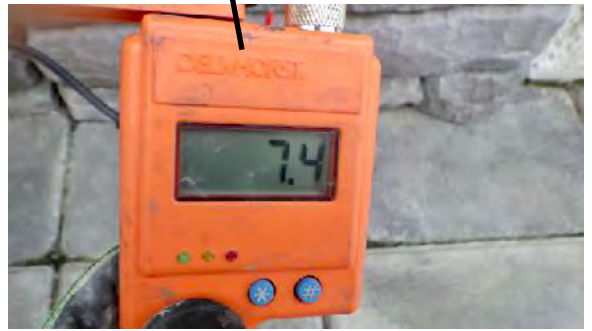
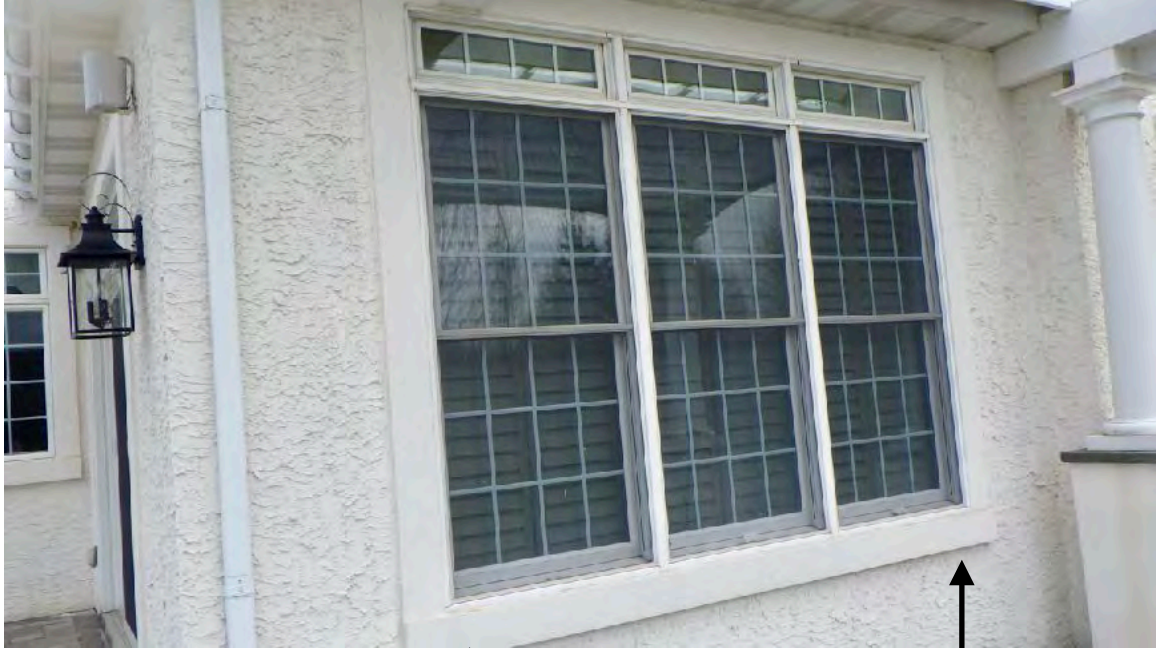
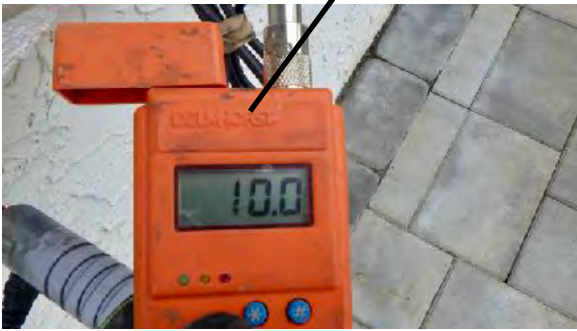
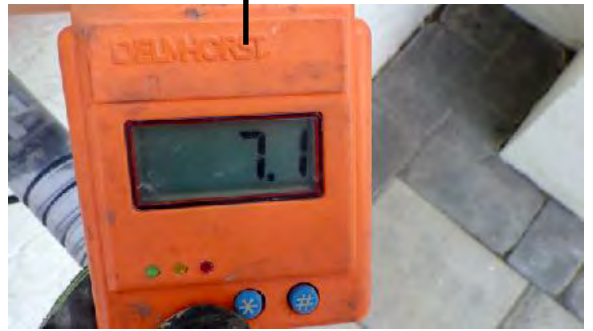
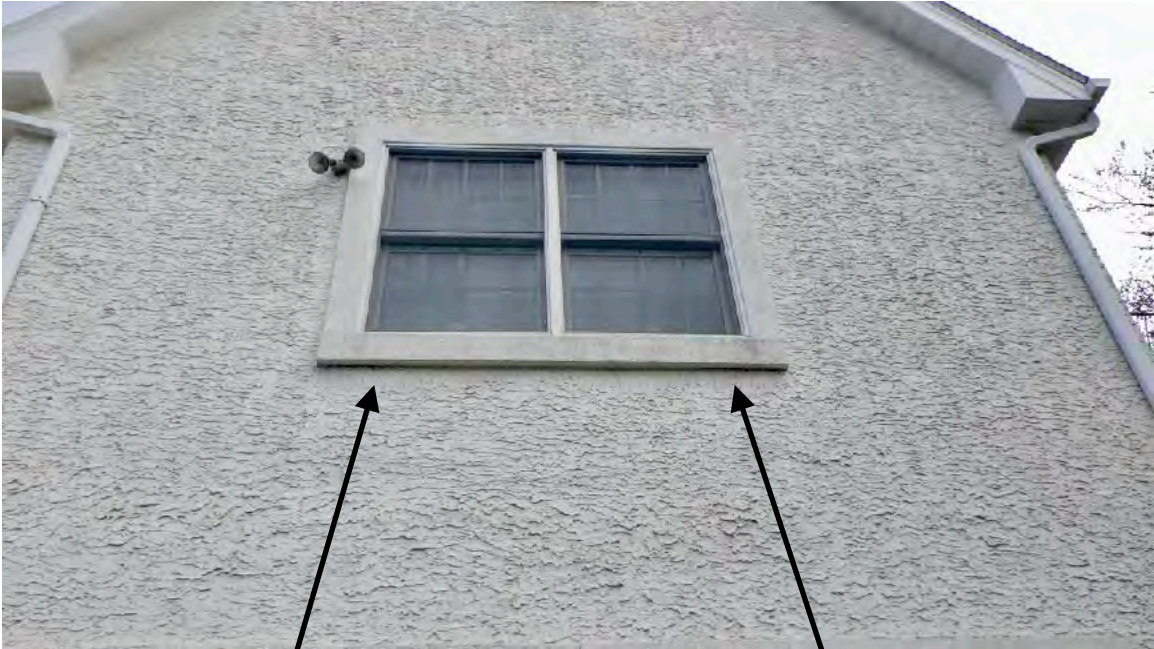
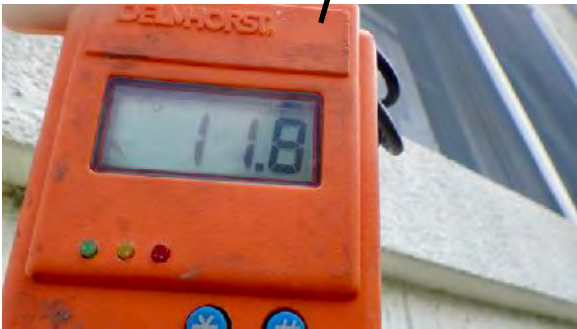
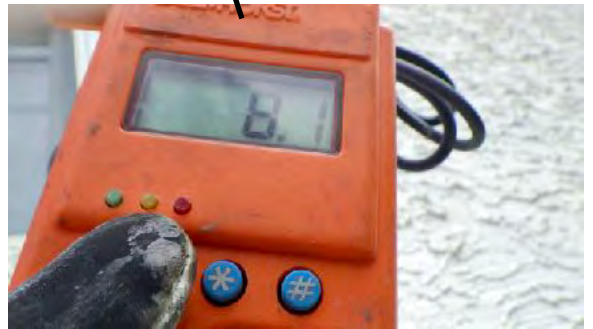
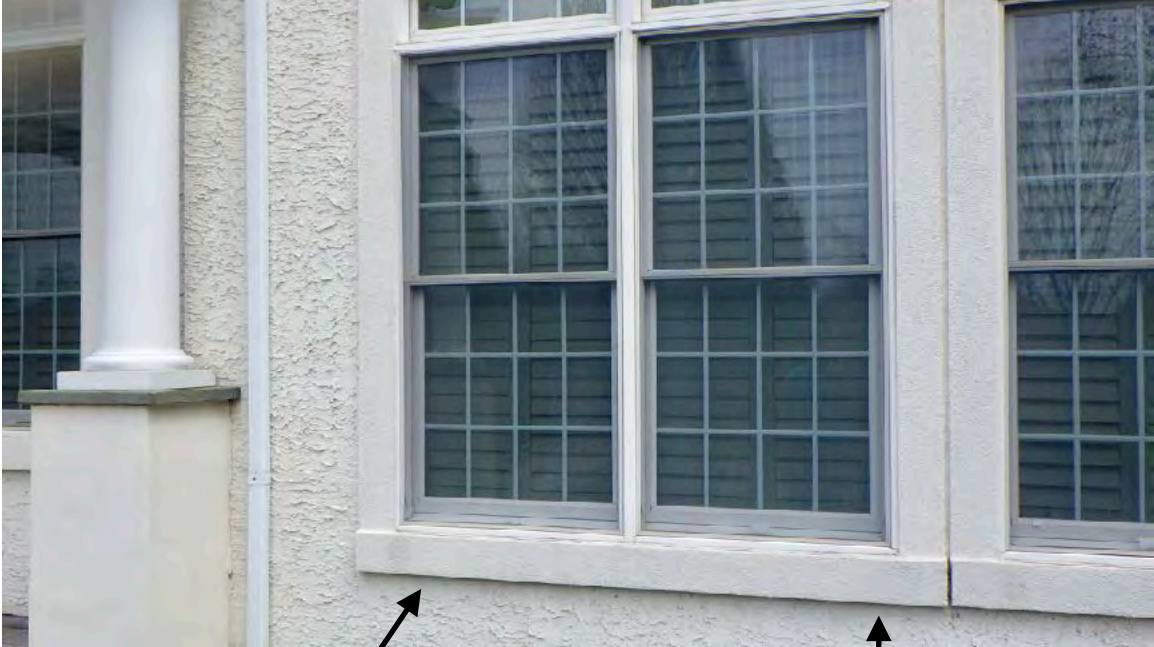
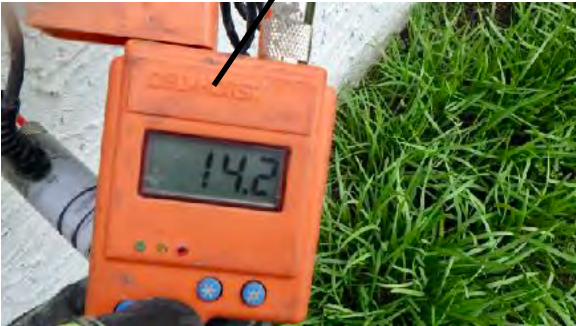
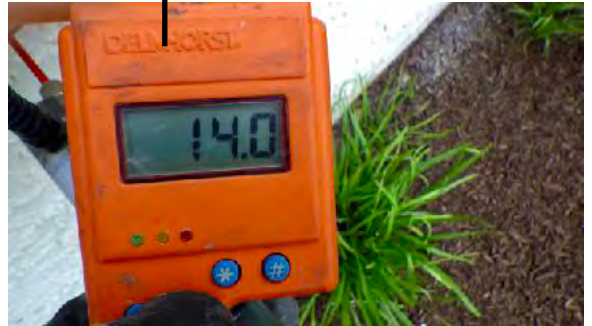
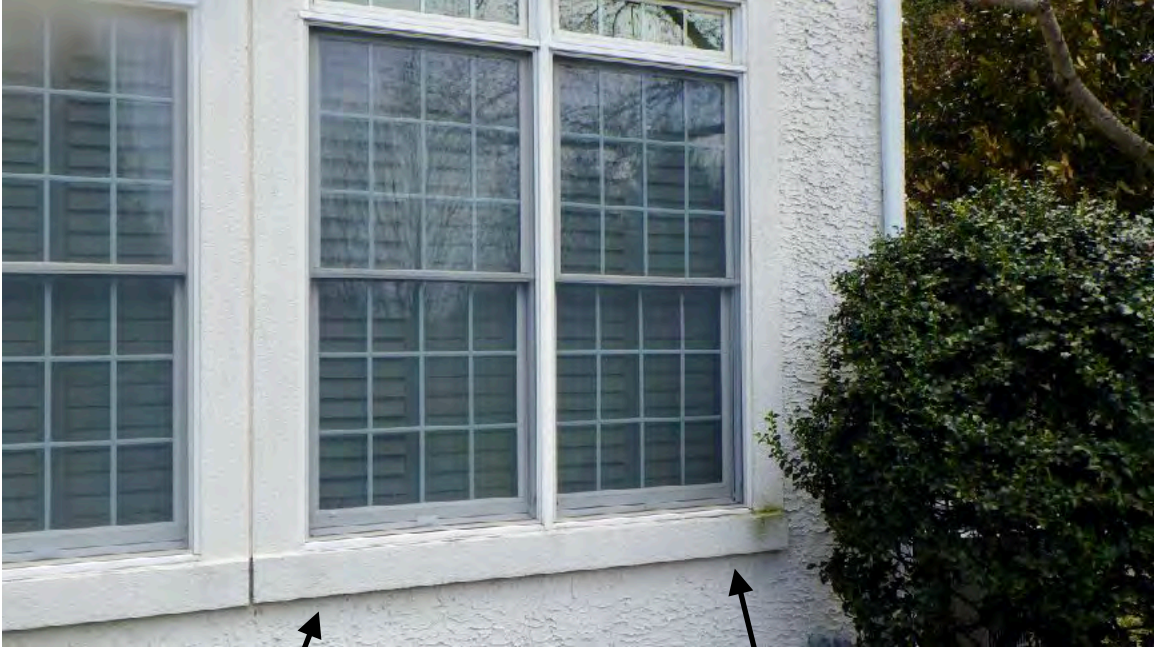
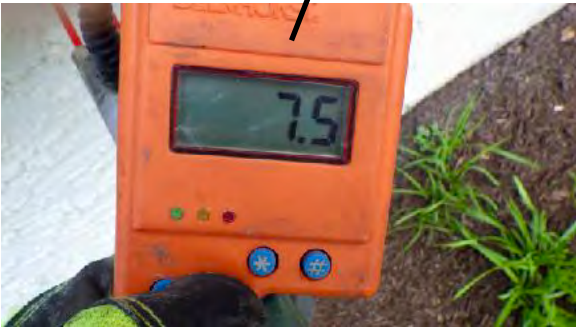
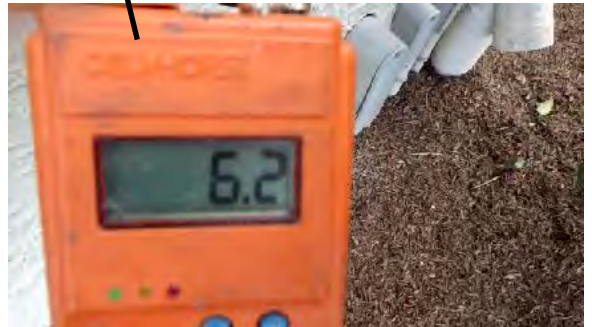
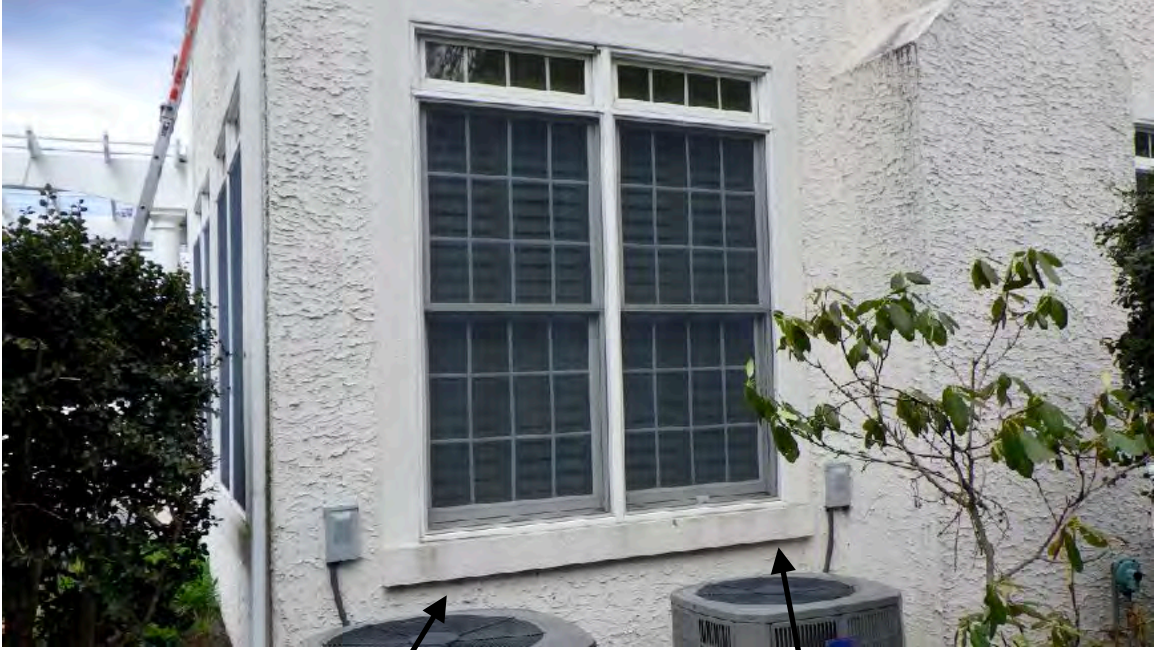
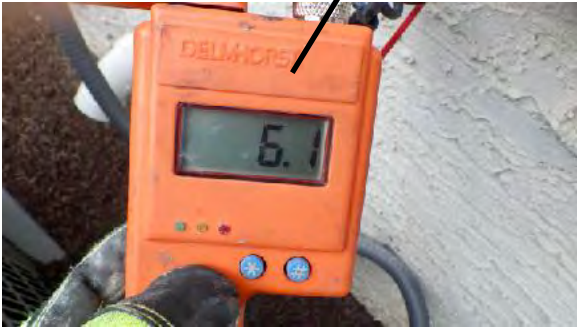
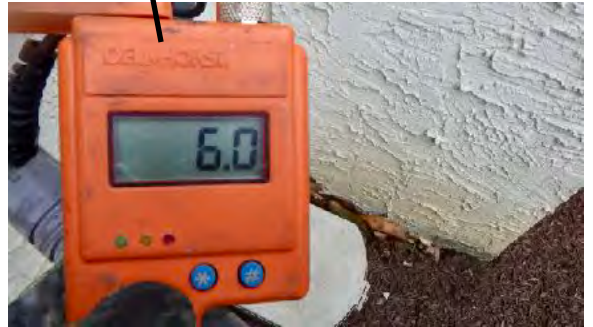
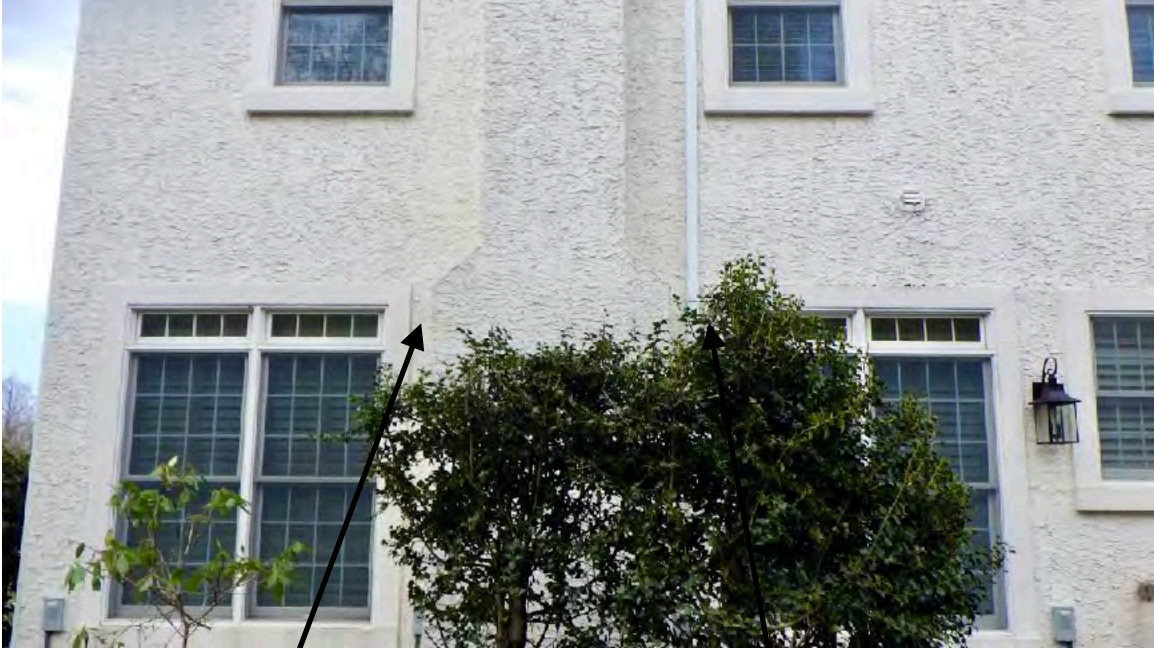
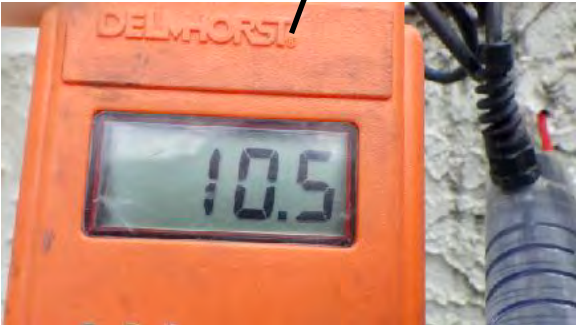
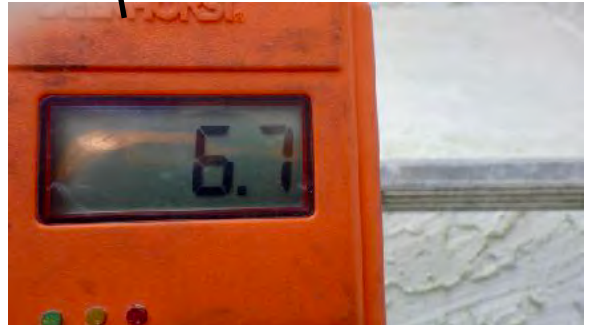
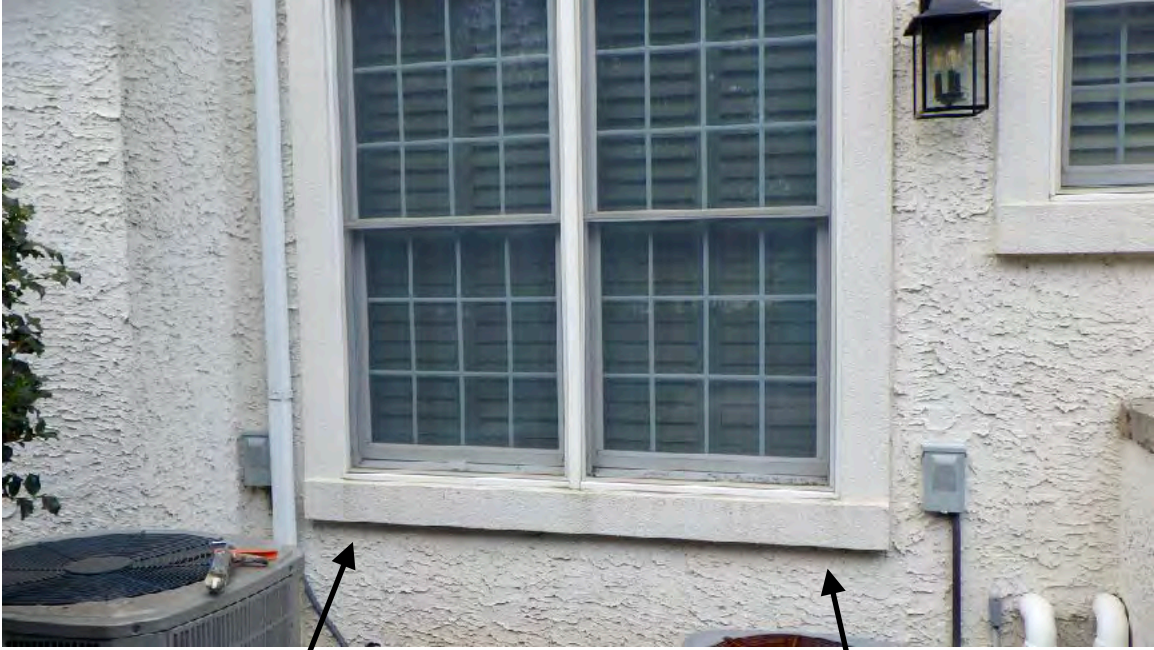
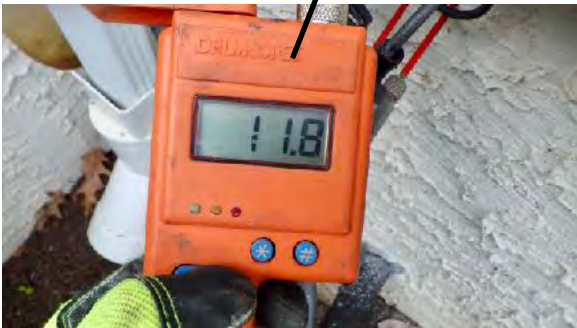
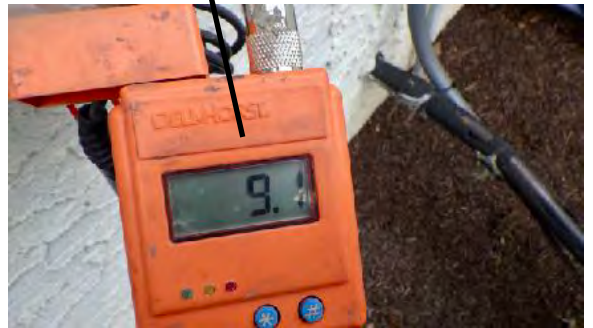
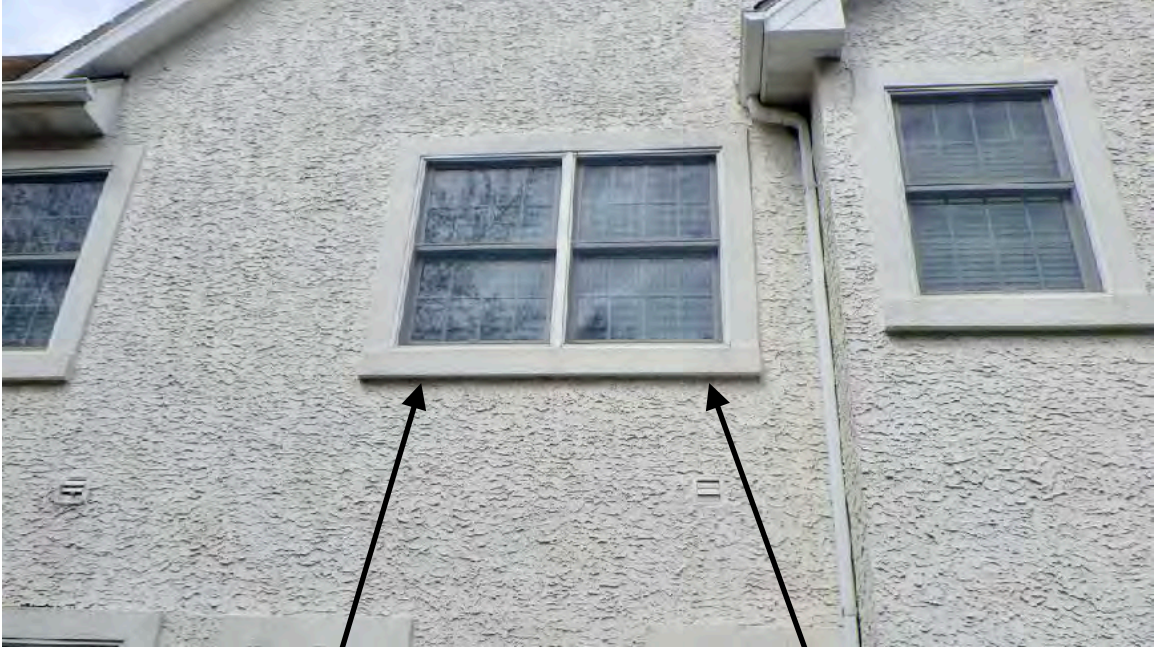
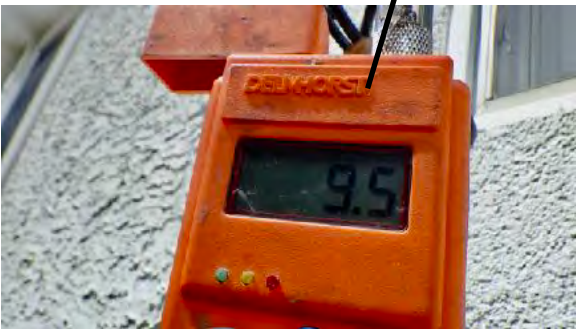
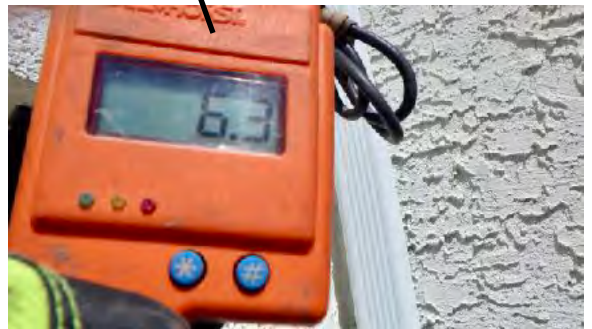
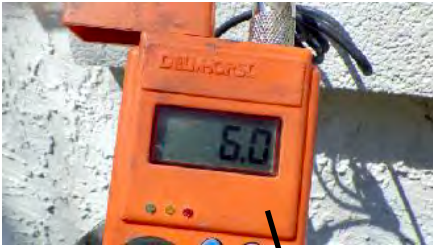
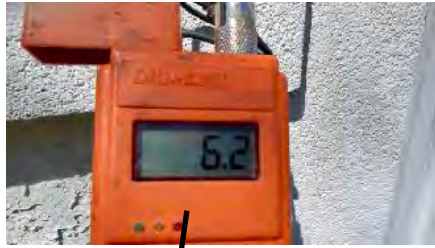
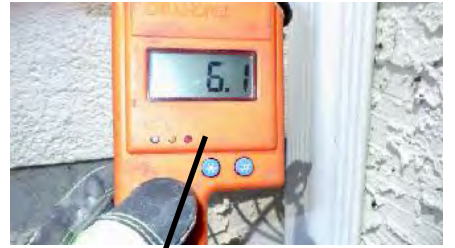
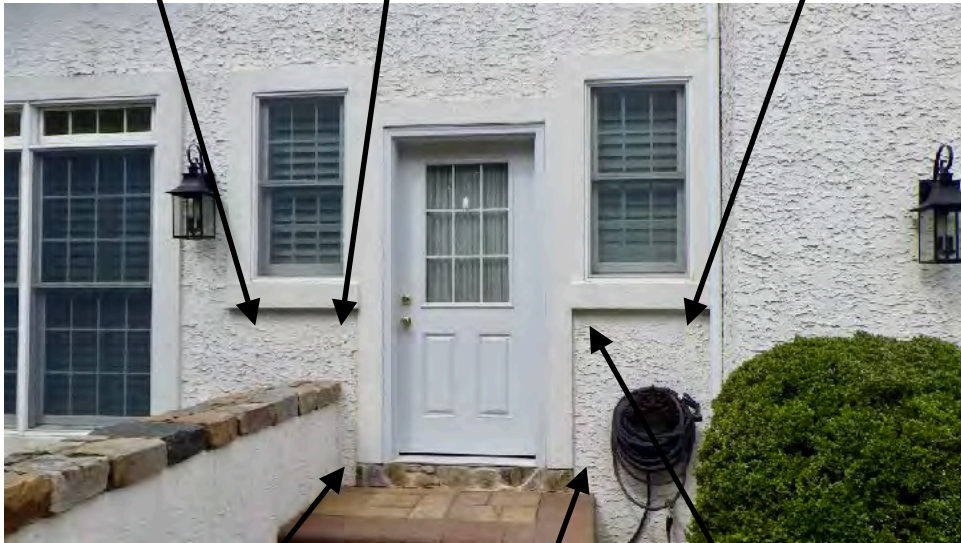
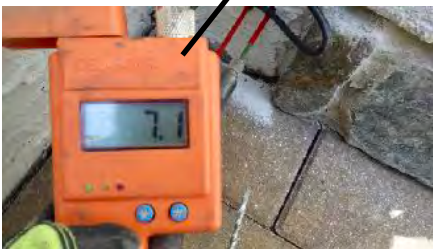
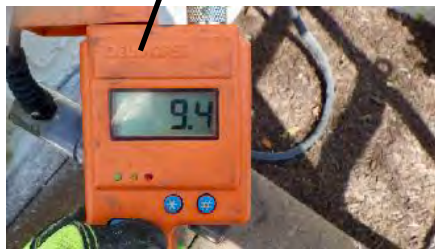
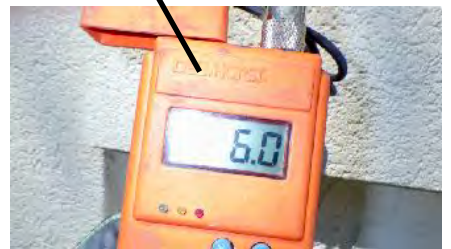
I only checked the noted windows and doors (vulnerable areas). See the pictures for moisture readings.

**Reading within specs and sheathing firm.
Common crack in stucco above soffit, allow for
repair.**

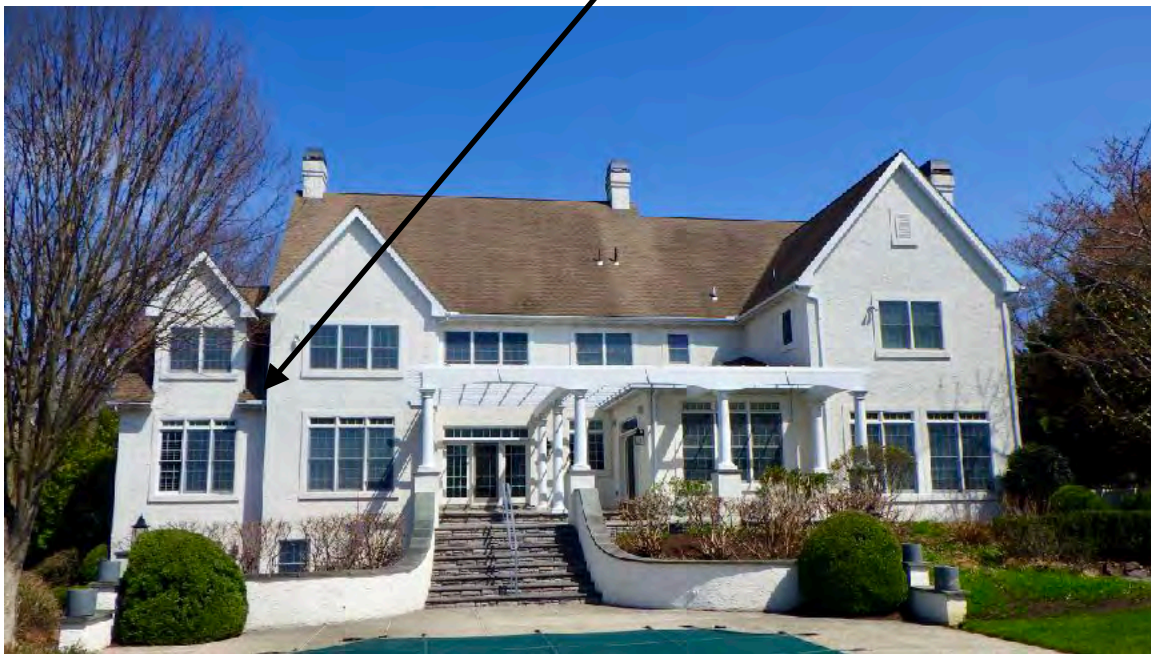
The stucco was not installed according to the modern ASTM Standards that were created in 2003,

2006 and 2009. Stucco working by design, allow for repair on left rear of property.
